NON-DESTRUCTIVE MONITORING AND TECHNICAL EVALUATION CONDITIONS OF THE MONUMENT ALEXANDER III

The article presents the methods of non-destructive testing and evaluation of monuments of cultural heritage, verified by the example of technical analysis of the structure and the defective condition of the monument to Alexander III (St. Petersburg). The methodology includes a set of scientific and technical activities and consists of several blocks of analysis of the composition of materials and design features: visual-optical, capillary, acoustic-ultrasonic, acoustic-ultrasonic pulsed, thermal-imaging, X-ray fluorescence and metallographic.

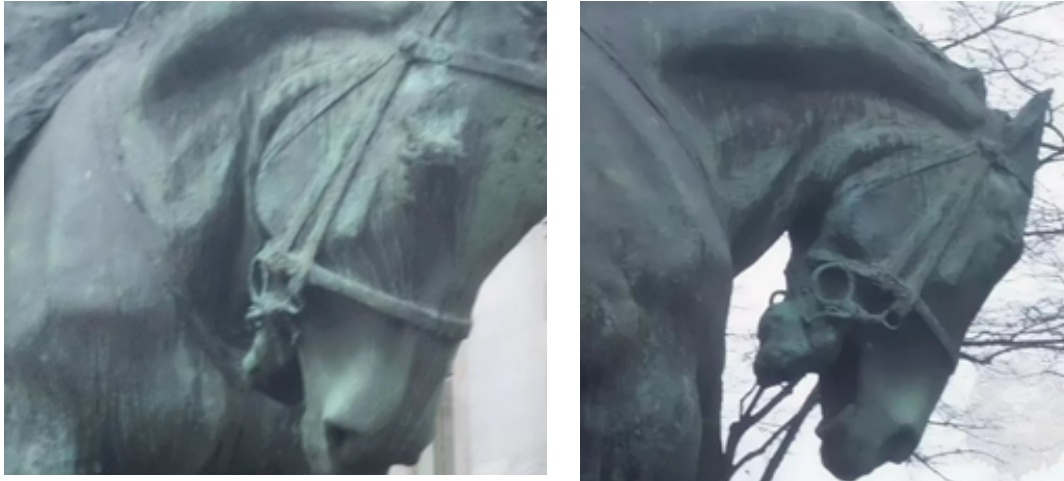
Figure 3. The scheme of elements of the monument to Emperor Alexander III – the head of the horse.

The horse's head is connected to the horse's body with bolts (15 pieces), the heads of which were cut off after mounting. The upper part of the coupling has a gap of 2 mm. In the lower part of the interface, corrosion products and traces of unidentified seal material are visible.

With the help of a thermal imager, significant gaps (up to 35%) were identified along the line of conjugation of the horse's head (weight more than 1.5 tons, length 1.7 meters).

There is a hole of irregular shape measuring 50x60 mm, partially filled with zinc in the horse's head between the ears. Bronze around the hole is thinned to 5-10 mm.

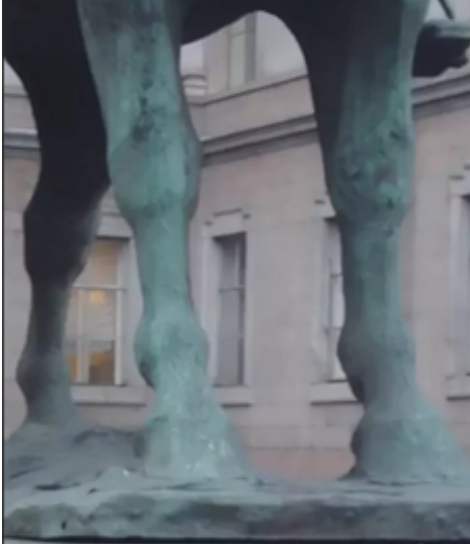
Figure 3. The scheme of elements of the monument to Emperor Alexander III – the front part of the horse.

Cavities. There are small cavities on the surface of the monument. The largest number of them is in the front part of the horse's chest of 5–15 mm long, 5–10 mm deep.

Seals. The sealing of the hole with a diameter of 85 mm in the horse's mouth with a zinc-based alloy is in good condition.

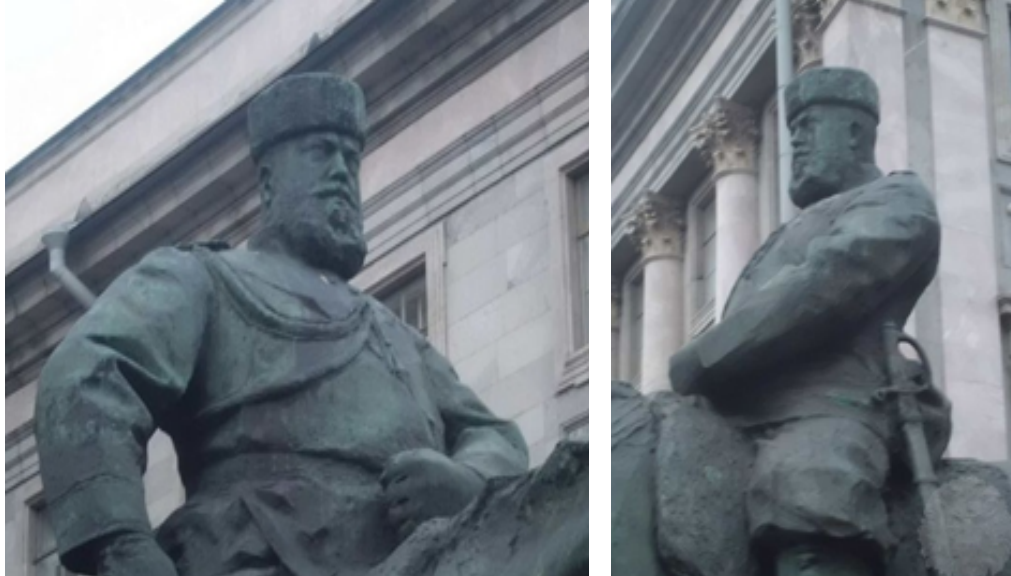
Figure 5. The scheme of elements of the monument to Emperor Alexander III – the figure of Alexander III.

There is a hole with a diameter of 6 mm on the rider's boot. There is an oval opening measuring 12 × 7 mm in the right thigh of the horseman. There is a hole of 25 × 15 mm on the outside of the boot, the hole in the top of the fist of 80 × 20 mm. The metal around the hole is thinned. There is a threaded hole of M10 size in the index finger.

There are cast defects such as scabs caused by penetration of molding mixture pieces into the metal during the hardening process. One scab with a size of 70x40 mm and a depth of 30 mm was found in the lower part of the arm.

A large number of seals is in the rider's figure. Obviously, a fragment of 100 × 200 mm is welded in the upper part of the saddle. On the right side of the saddle there is a seal with bronze 130 × 120 mm in size. There are seals in the plinth.
