THE 30TH OF OCTOBER SAMOS-GREECE EARTHQUAKE. ISSUES RELEVANT TO THE PROTECTION FROM STRUCTURAL DAMAGE CAUSED BY STRONG EARTHQUAKE GROUND MOTIONS

George C. Manos
Editor in Chief
Professor Emeritus, Aristotle University of Thessaloniki
Thessaloniki, Greece

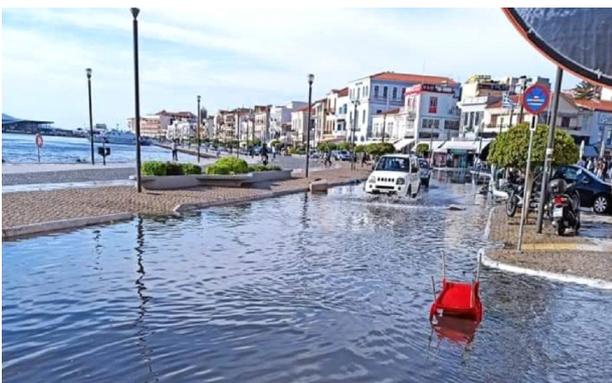
A few minutes after the main shock the waterfront of Vathi was subjected to a tsunami which, despite its relatively small height, flooded the shops located at the waterfront causing considerable damage to its contents (Figure 4). Moreover, a permanent uplift of approximately 20cm was noticed at the embankment

Samos Earthquake 30-10-2020, Damage from the main event at the city of Vathi, capital of the island of Samos. The interior of the shops at the water front was damaged by a tsunami that followed a few minutes after the main shock

Figure 4. Indication of the tsunami at the waterfront of Vathi

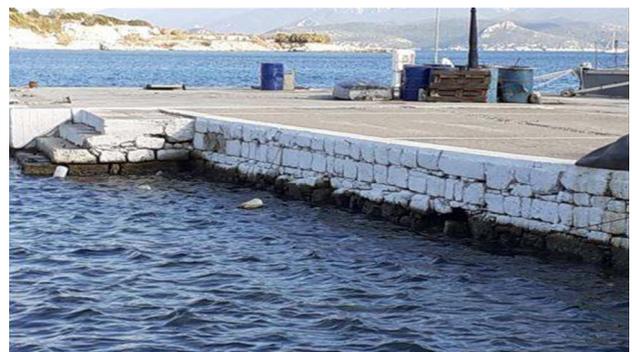
Samos Earthquake 30-10-2020. There were signs of 20cm land rise at the water front.

Figure 5. Permanent uplift of the embankment at the waterfront of Vathi

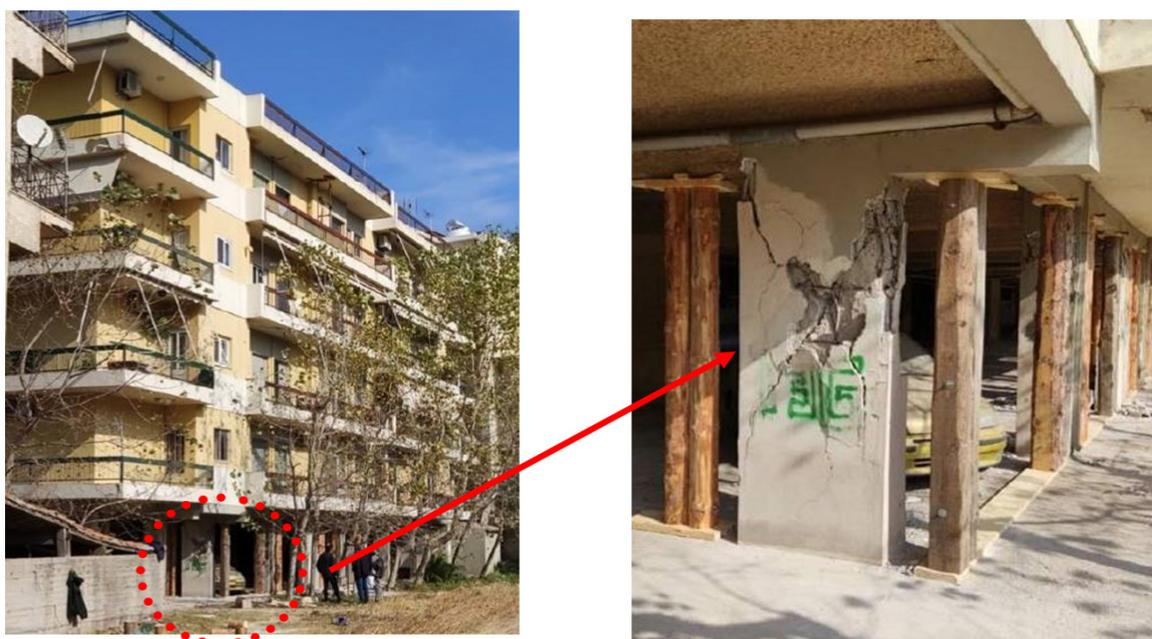
As already mentioned, in contrast to the collapsed multi-story buildings at Izmir-Turkey (Figure 7), fortunately very few reinforced concrete buildings in Samos Island sustained structural damage. Figure 8 depicts such a case of damaged columns at the ground floor of a RC multi story building. This particular structural deficiency of a “relatively” flexible ground floor for RC multi-story buildings in Greece has been identified for some-time (see Manos, 2011) This is due to the fact that the shear force demands at this level are amplified because of the increased stiffness of the upper floors, which is not accounted for in design that ignores the influence of well-built masonry infill in these upper floors. Moreover, the old design provisions did not focus on shear reinforcing detailing of these ground floor columns to provide for sufficient shear strength to meet such shear amplified demands.

Unfortunately, this structural deficiency which leads to such high-risk structural damage for the safety of RC multi-story buildings is systematic and is present in numerous RC multi-story buildings designed and constructed in Greece prior to the enforcements of the provisions of the New Seismic Code of Greece in 1995, as was shown by the earthquake damage observations of Kalamata 1986, Pyrgos 1993, Kozani and Aigio 1995 and Athens 1999 (see Manos, 2011). Another particular structural deficiency is the “accidental” formation of short columns in RC framed structures again by building strong infill in various openings. These two structural deficiencies have been identified from past

Figure 8. Shear failure of columns at the ground floor “soft” story of RC multi-story buildings at Samos island (ETAM report Nov. 2020 (Preliminary report, November 2020))

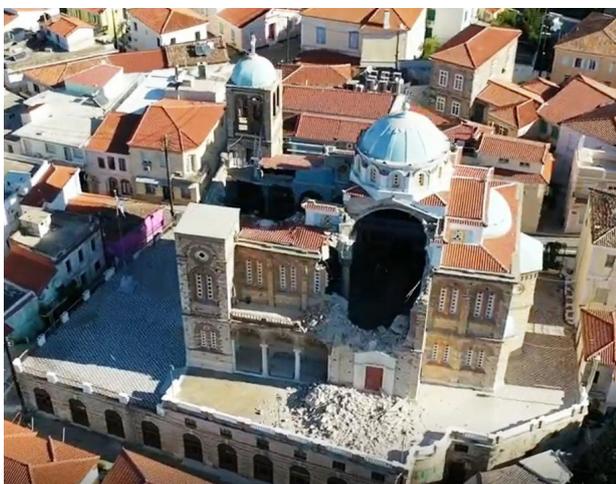
Figure 10. The collapsed parts of the domes at the West and North part of this church

the superstructure domes that are collapsing next in a sequential order. This is clearly indicated by figure 10 depicting the collapse of part of the Southern part of the transept by the out-of-plane collapse of the peripheral wall and the corresponding part of the superstructure. This is also indicated up to a point in figure 13. However, this time the partial collapse of the upper part of the peripheral wall was not followed by the sequential collapse of the supported superstructure.

4. The mechanism of the collapsed Western part of the central nave shown in figures 10 and 11 is more complicated. This may be due to the role of the $\frac{1}{4}$ spherical domes that bridges the space between the Western semi-cylindrical dome with the roof next to the central dome and the Western peripheral wall. This $\frac{1}{4}$ spherical dome is followed by a semi-cylindrical dome till it reaches the somehow elevated semi-cylindrical dome covered by the wooden roof with the tiles. The actual support conditions of this $\frac{1}{4}$ spherical dome are not known. Moreover, unknown are also the connection conditions of this part of the

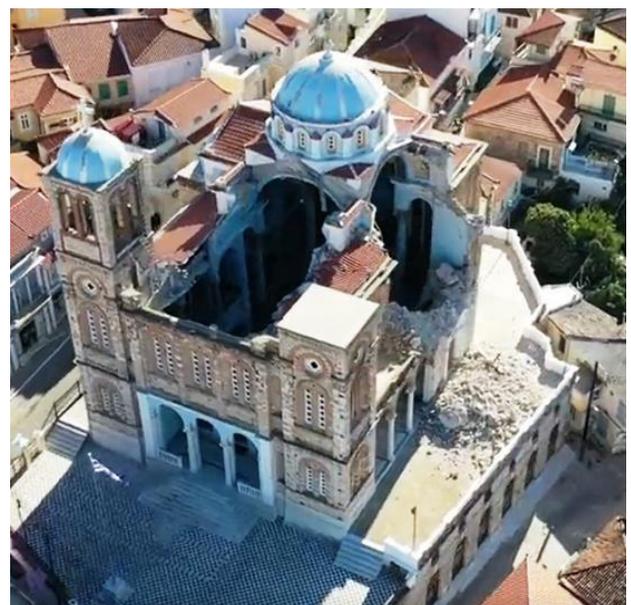
Figure 11. The collapsed parts of the domes at the West and North part of the church

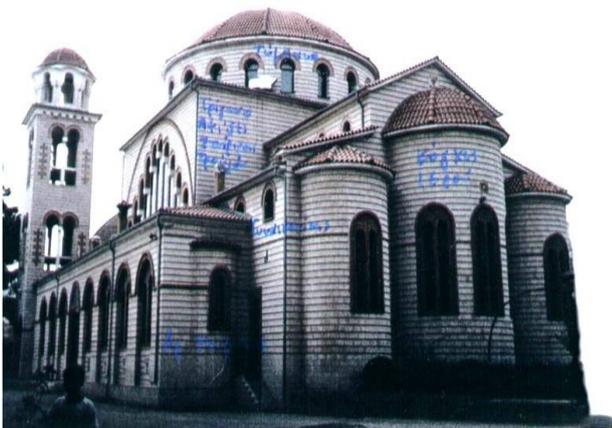
1. The structural system of the church of Agiou Konstantinou kai Elenis at Kozani (Figure 11) is similar to the one depicted here. This church was studied extensively by Manos (1997) and Soulis and Manos (2019) in order to understand the mechanisms that generated the structural damage it sustained during the 1995 earthquake sequence and propose a retrofitting scheme that was constructed in order to strengthen its earthquake resistance (Manos

et.al., 1997; Soulis and Manos, 2019; Manos, Soulis, Diagouma, 2008). It was shown from this investigation that large seismic forces are generated by the considerable masses of the spherical and cylindrical domes that form the superstructure and the combination of relevant eigen-modes excited by the characteristics of the horizontal components of the seismic ground motion. These seismic forces are generated at considerable height and are resisted mainly by the peripheral stiff unreinforced masonry walls whereas the internal colonnades provide minimal resistance to these horizontal seismic forces due to their relative flexibility.

Figure 12. The church of St. Konstantinos and Eleni damaged by the 1999 Kozani-Greece earthquake (Manos et.al., 1997; Soulis and Manos, 2019)

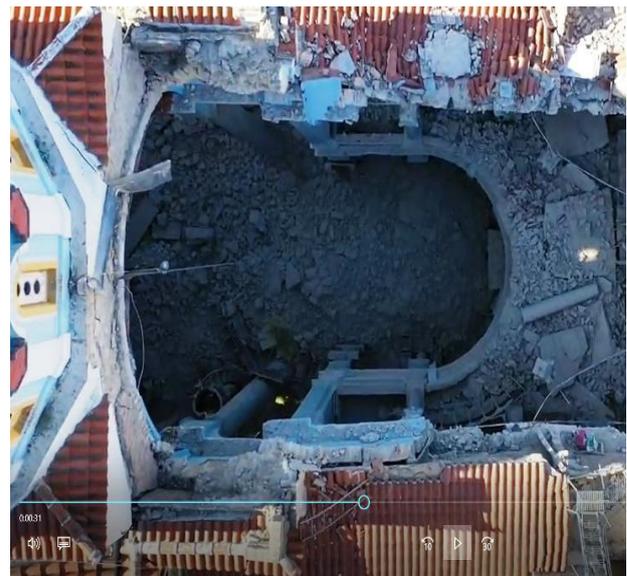
superstructure to either the adjacent dome or to this peripheral West wall. Figure 14 suggests that both these support and connection conditions failed and contributed to the loss of support of this part which, because of its considerable weight, could not be supported and this led to its collapse.

Figure 14. View of the collapsed Western part of the central nave

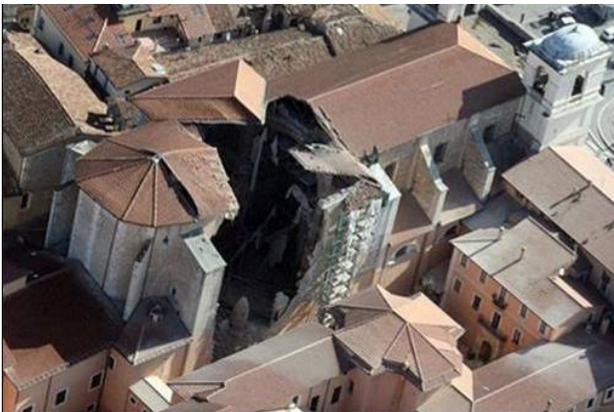
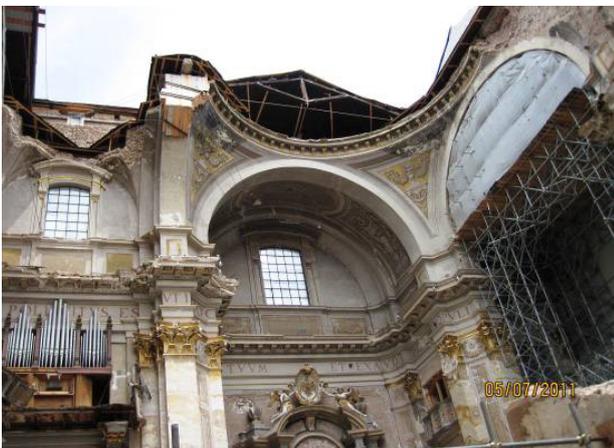
Lagomarsino, 2011; Modena et.al., 2010). Certain similarities can be seen between the observations made here in figures 10, 11 and 14 and the L'Aquila damage depicted in figure 16.

Figure 16. The church of St. Giorgio damaged by the 6th of April 2009, L'Aquila-Italy, earthquake sequence (top and bottom)

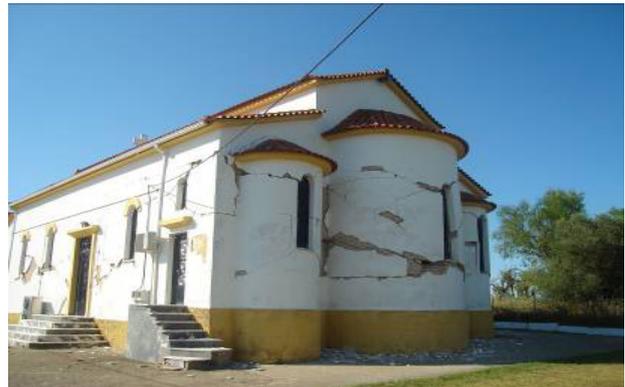
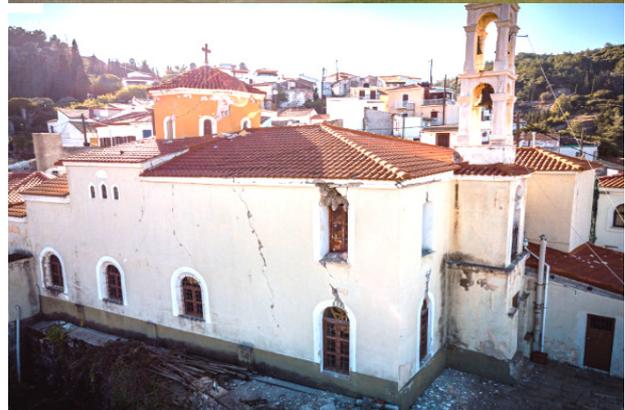
Figure 17. Typical damage to the peripheral masonry walls of "Basilica" churches from earthquake activity in Greece. At the top, a "Basilica" church at the village of Nisi from the Patras-Pyrgos earthquake of 8th June, 2008. At the bottom, a "Basilica" church at Karlovasi damaged from the Samos earthquake of 2020 (Manos and Kozikopoulos, 2015; Manos, Soulis, Karamitsios, 2012; Manos and Karamitsios, 2013; Manos, 2016; Manos, Kotoulas and Kozikopoulos, 2019; Manos and Kotoulas, 2019)

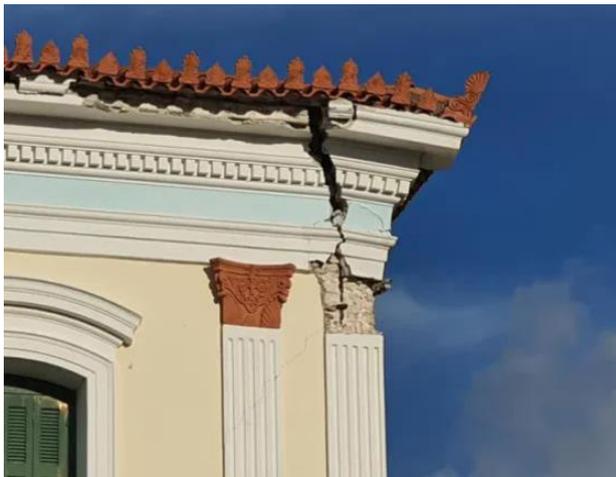
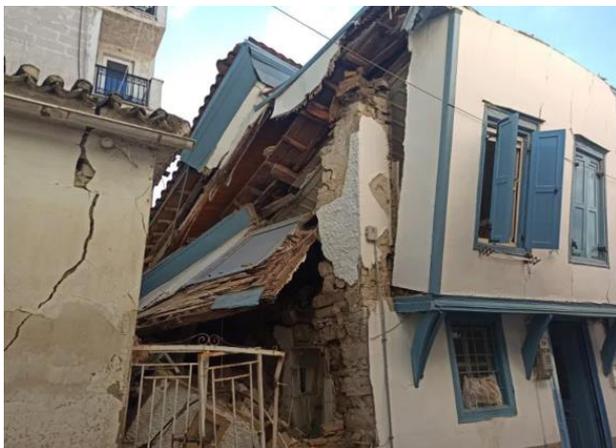
Figure 18 depicts the structural damage of low-rise buildings at Vathi sustained by the Samos earthquake of 30th of October 2020. Many of such buildings located at various urban areas in Greece are under special conservation status due to architectural features or historical significance. However, many of these buildings are left without either serious maintenance or the necessary

Figure 18. Damage of old low-story buildings at Vathi. In need of preservation because of particular architectural features

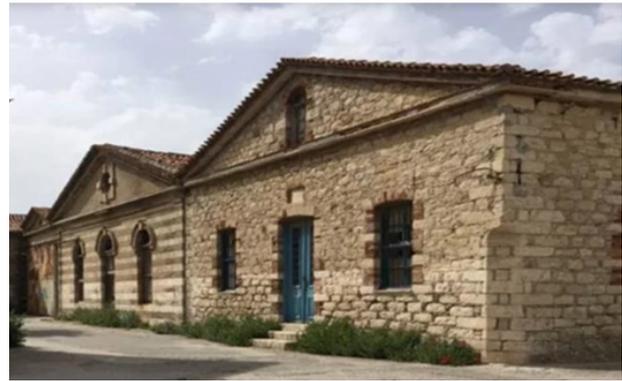
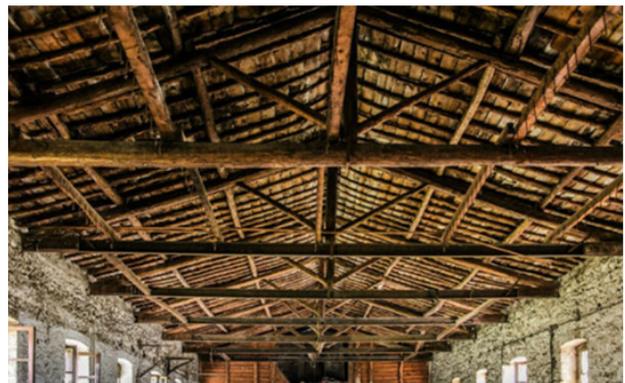
Figure 19. Old industrial buildings under conservation status

The buildings in figure 19 are old industrial buildings, named “Tampakika” being under conservation status in Karlovasi at Samos island. Initially, these buildings were built at the end of the 19th century, near the sea-shore of Karlovasi, as factories for the processing of leather. This activity was very prominent from 1880 till the beginning of World War II. After this, the leather processing in this part of the island started to decline having as a result for these buildings to be abandoned after few decades. Many old buildings were listed as part of cultural heritage under conservation status at the beginning of 1980. However, the effort for their maintenance and retrofitting has been, as explained before, relatively slow

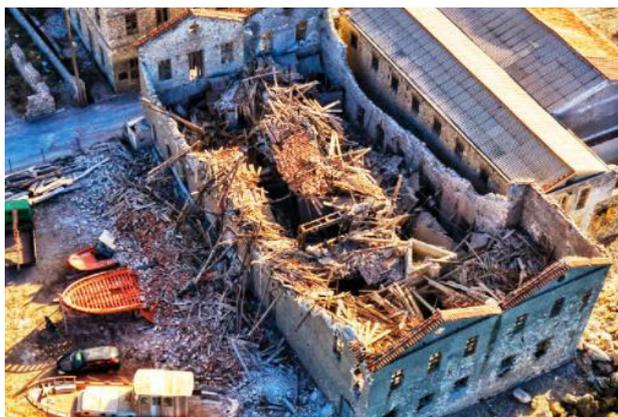
as shown in figure 22. The observed damage was of the typical form of loss of support and collapse of the wooden roof accompanied by the partial out-of-plane collapse of the long peripheral walls. The location of these buildings is shown in figure 21.

Figure 22. The partial collapse of one of the industrial buildings at the seafront of Karlovasi

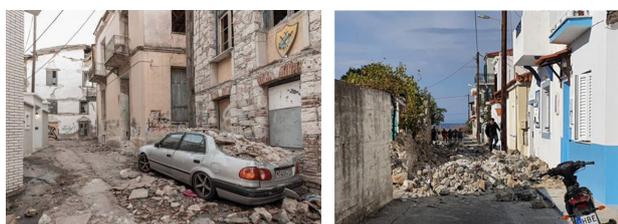
A final topic of interest is the partial collapse of low-story unreinforced masonry buildings causing the deadly injury of two young teenagers at the city of Vathi. Despite the low-rise of these buildings, the deadly event was caused by the considerable weight of the falling parts and the narrow streets in the old part of the city that inhibit any escape. This is depicted in figures 23 and 24. As a result, a special legislation is on the making for allowing the technical services of each municipality to order the demolition of old properties that are left without the proper maintenance of their owners and can be judged as representing a possible risk by partial collapse in the eventuality of a future earthquake. Again, for this type of problems the issue is partly technical and partly social-economic. The new legislature provides that the demolition cost will be initially paid by the municipality and then claimed back to be paid by the owners.

Figure 23. The partial collapse of old unreinforced masonry structures at Vathi that caused the death of two young teenagers

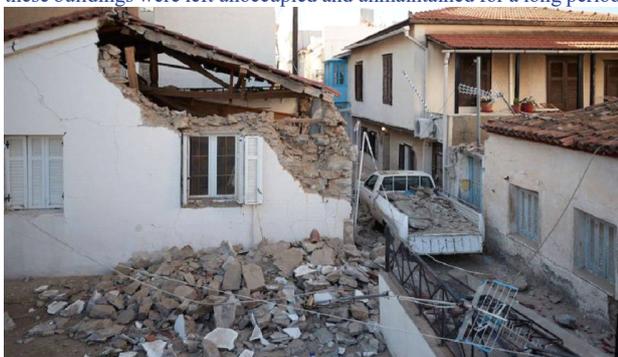
Samos Earthquake 30-10-2020, Damage from the main event at the city of Vathi, capital of the island of Samos. The most severe structural damage was related to unreinforced low-rise masonry buildings. Some of these buildings were left unoccupied and unmaintained for a long period

Figure 24. The partial collapse of old unreinforced masonry structures at Vathi that caused the death of two young teenagers

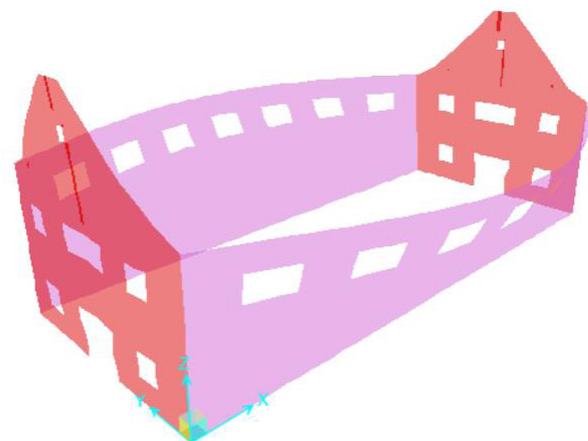
Figure 30 depicts the maximum displacement response for the load combination Dead + 0,3 ResSpec x-x + ResSpec y-y. As expected, the peak out-of-plane U_y displacement at the top of the longitudinal peripheral walls (the ones parallel to the x-x direction) become larger as the stiffness of the wooden roof with the masonry peripheral walls becomes smaller. The results of this relatively simplified numerical analyses explain, up to a degree, the observed damage sustained by these old industrial buildings during the recent 30th of October, Samos earthquake (Figure 22).

Figure 30. Displacement response from the load combination Dead + 0,3 ResSpec x-x + ResSpec y-y
