## DISMANTLING AND RECONSTITUTION OF PRASAT SUOR PRAT, ANGKOR THOM, CAMBODIA

### Abstract

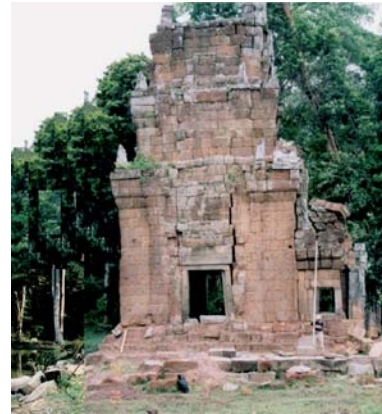
Photo 2. N1 Tower, Prasat Suor Prat

One of the 12 towers named as N1 that had been inclined about 5degrees northwards was selected by JSA for safeguarding work as shown in Photo 2. The tower consists from a main tower with a front room called antechamber. The main tower is three story masonry structure with laterite bricks with 10m in width at foundation and about 20m in height. The inside of the tower is hollow structure with four open windows at every wall. Fig.6 shows vertical section and plan view of the N1 tower nearby the north pond.

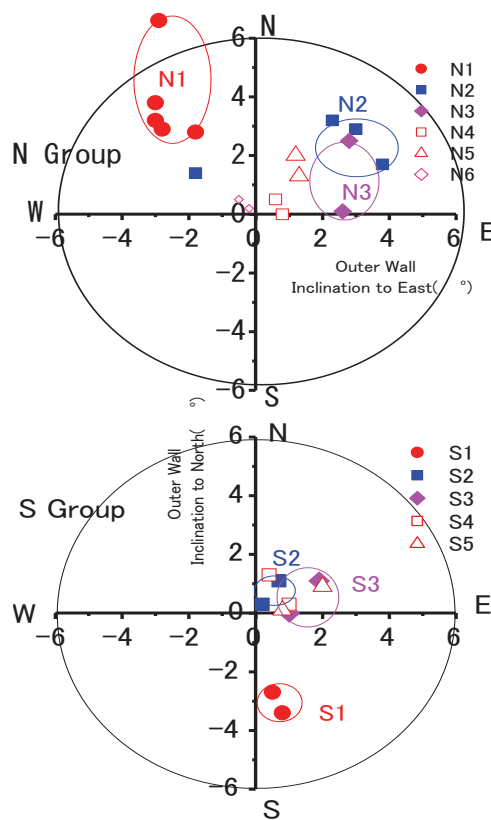
Fig.5. Inclination of Towers

Prasat Suor Prat (Tower of Rope Dancer) is a group of 12 independent towers along the west side in the Royal Plaza as shown in Photo-1 and in Fig.4 of plan view. These towers are divided into two groups of North and South. The inclination of side walls for all the towers at Prasat Suor Prat were measured and listed in Table1 and shown in Fig.5. Inclinations of the towers are less than 2-4 degrees except N1 and S1 and with direction of NW to NE. N1 and S1 show the largest inclination among each

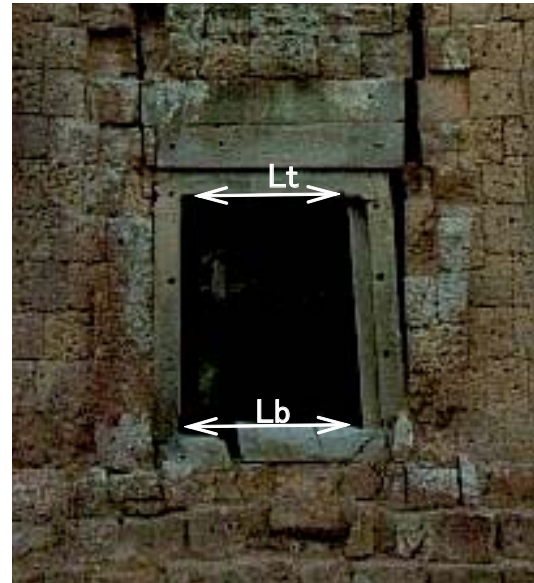
Photo 3. Deformed frame of open window at west side

The open window of the west wall is deformed as shown in Photo 3.

measured results are shown in Table-1. The laterite blocks of the side face of the foundation were found widened about 6-8%. One of the characteristics of the deformation of the foundation of N1 Tower is horizontal spreading. Fig.8 shows two major trends of deformation in the foundation system of inclination towards the North pond and horizontal spreading.

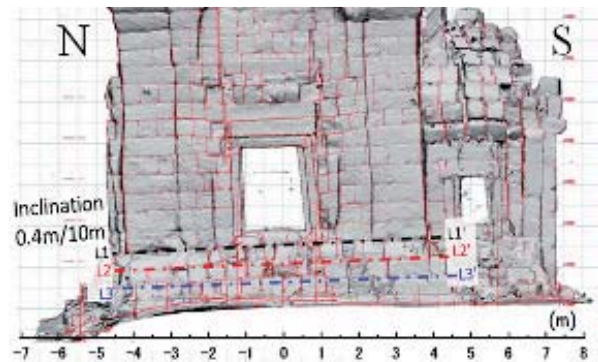
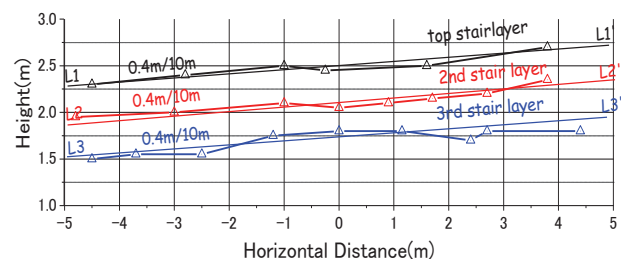
Fig.7 Inclination of step stones at the west side, N1 Tower

The horizontal line of side face stones of foundation mound was inclined to northwards. The levels of upper surface of the top (L1), the second (L2), and the third (L3) lines in the upper part of Fig.7 were measured at several points and plotted in the lower part of Fig.7. The inclinations of these side stones of the foundation mound were found about 0.4m per 10m of horizontal distance. The inclination of the foundation as well as upper structure suggested that the inclination of the Tower might have been caused by such ground deformation as sliding failure.

from Main Tower and Antechamber. The bottom level of the upper structures was the same level of top level of side step stones. As already stated, the top level of step stones had inclined to northwards with settlement of 0.4m for horizontal length of 10m as shown in Fig.7 and also indicated in Fig.8 as well.

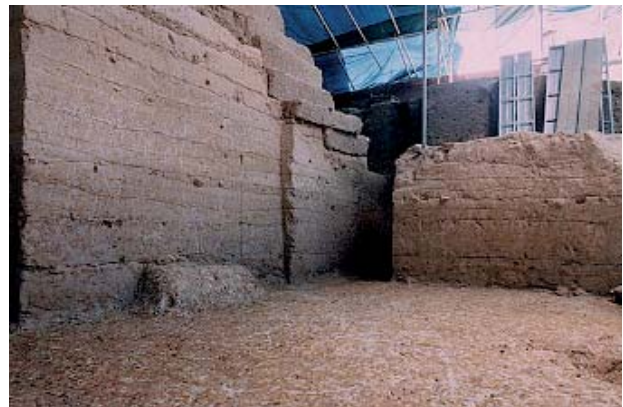
Photo 5. Trenched EW section (note the horizontal layers)

When the trench proceeded to the level of +0.00m, the manmade compacted sand layers were exposed. We had expected the same inclination of the compacted soil layers in the foundation mound. However, amazingly, we found the manmade layers of soil mound formed almost horizontal layers as shown in Fig.8. It was mysterious for us to understand until the excavation reached to the much lower level.

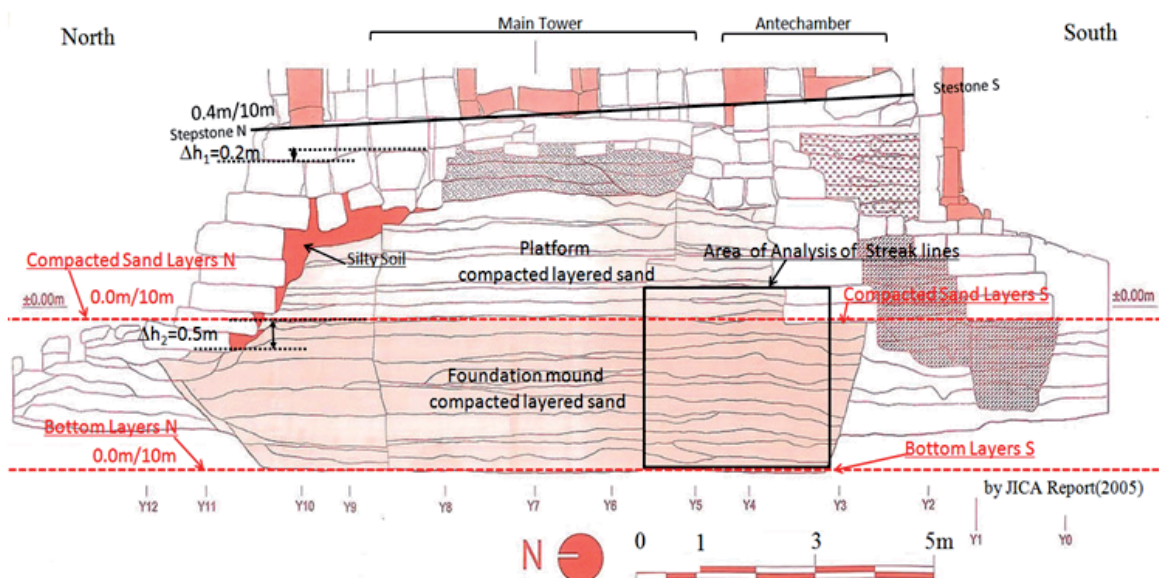
Fig.8. Trenched section along N-S direction

When the trench was further deepened, the section in the north side of the foundation mound showed a small local bearing failure at horizontal point Y11 in Fig.8, which had resulted in sliding of retaining slope of north side face. The bottom element of side stones had settled by about

$\Delta H_2=0.5\text{m}$  from the original level. The bearing failure took place for the bottom of the step stones. It should be noticed that the bottom of the step stones settled about 0.5m, however, the highest block of the step stones was found settled only  $\Delta H_1=0.2\text{m}$  as shown in Fig.8.

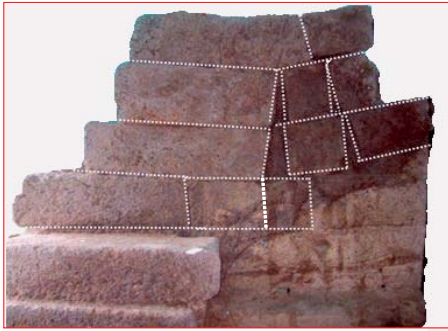
Photo 6. Side stone at north face

Photo 6 shows the deformation of step stones at north side. The outer most stone settled and displaced outwards. Accordingly, the side stones behind the front stones were also displaced outwards but the horizontal displacement was less than the front stones.

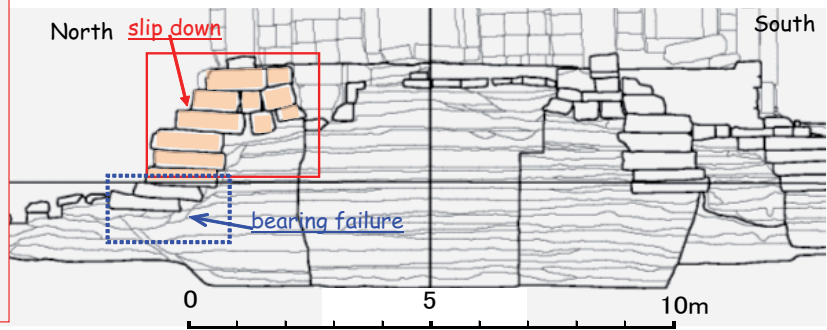
Fig.9. Mode of failure of step stones at the north side

It is estimated that the bearing failure at the base had been the initial step of the failure that caused to drag the upper step stones to slip down as shown in Fig.9.

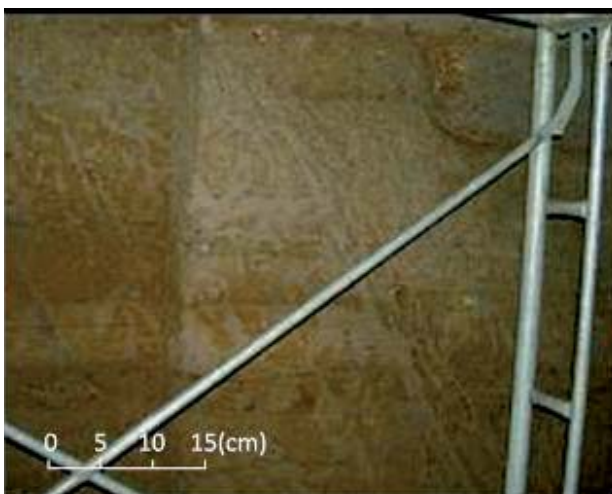
Photo 7. Streak lines on the trenched surface

As shown in Photo 7 and in Fig.10, many streak lines were found on the face of trenched section of platform and foundation mound. Based upon the photos of the sections, the streaks were analyzed in the part of squared section of “Area of Analysis of Streak lines” shown in Fig.8.

Since the internal frictional angle of sand obtained by laboratory test was 30 degrees,  $\theta$  become 30 degrees when the vertical overburden stress is the major principal stress. The appearance of these streak lines suggests that the foundation mound might have experienced plastic yielding under vertical load.

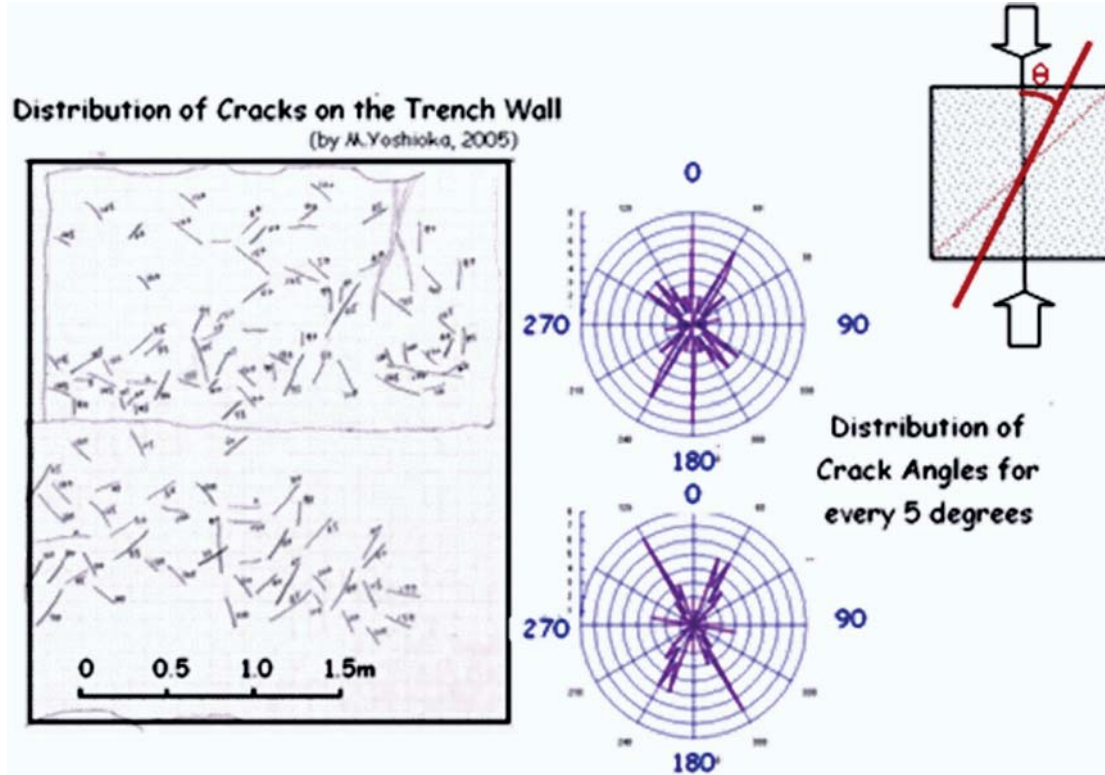
Fig.11. Sketch of streak lines in the section shown in Fig.8

The area shown in Fig.8 was further divided into two sections of upper and lower part as shown in Fig.11 and the distribution of the angle of streak lines were analyzed and the distribution patterns of the angles of streak line from the vertical line are plotted in Fig.12. The strong tendency of the angle of 30degrees from the vertical direction was obtained, which suggests the streak lines correspond to shear surface under failure.

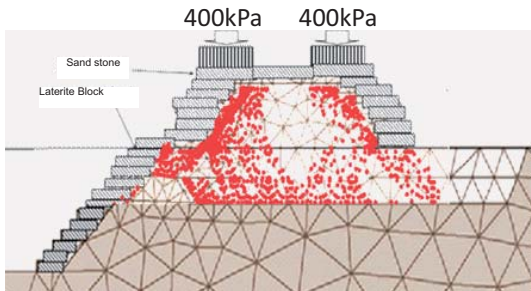
Fig.15. Plastic zone for loading of 400kPa

The estimated total weight of the upper masonry stone structure was 8.97MN which resulted in the vertical load of 421kPa at the top of the foundation. The maximum vertical settlement of 18.4cm was obtained at the surface level of the mound. Figs.15 and 16 shows the distribution of plastic zones and shear strain that were caused by the load from the
