ACCIDENT ANALYSIS OF LOW PRESSURE GAS DISTRIBUTION SYSTEMS

Alexander Shkarovskiy^{1,2}, Maciej Kotuła³

Abstract

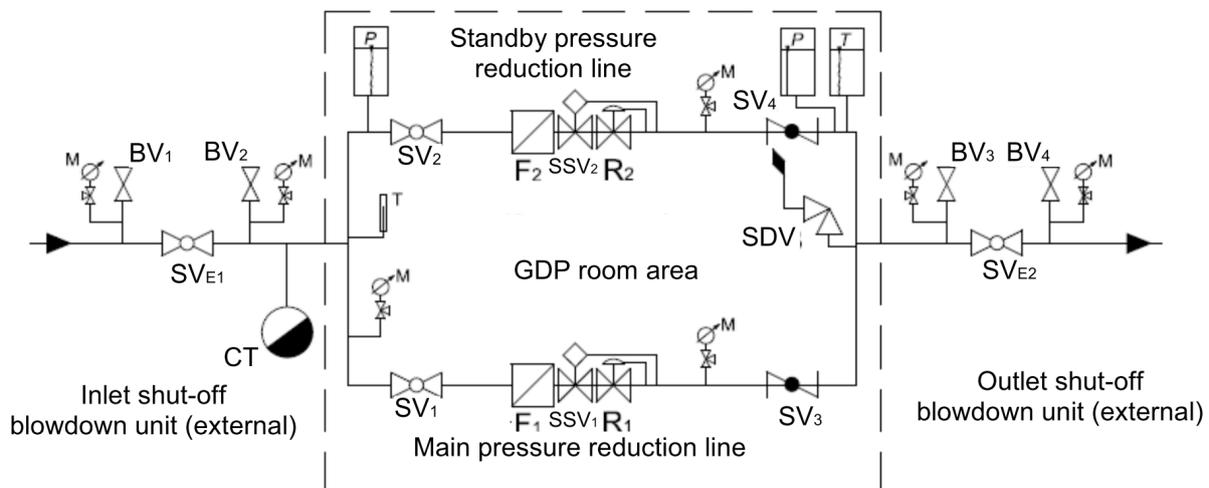
Note the reference to the failure of the shut-off valve particularly in the standby line. This indicates that the main pressure reduction line was simply turned off. Brief information on the layout of the gas distribution plant designed more than 40 years ago is needed at this point. The GDP was constructed based on a two-line pressure reduction layout (Figure 1). Both pressure reduction lines are placed in the GDP building; they are fully functional and identical but for the equipment settings. They share only inlet and outlet shut-off and discharge units located outside the building, and the safety discharge valve.

It was this line where malfunction of the pressure regulator occurred. Most likely, it was due to a damaged membrane. This ultimately led to a spike in pressure downstream of the pressure regulator. An emergency situation occurred (which was still standard one), and

Figure 1. Layout of the low-pressure GDP with two pressure reduction lines:

As can be seen, the situation would have ended in case of switching to the standby line, since the properly functioning pressure regulator would have started operating. But, as stated above, the GDP in question was not fully operational: *by that time, it operated through the standby pressure reduction line*, and both safety devices did not go off.

Speaking of the reasons behind the failure of the standby line safety shut-off valve to operate, it follows from the prosecutor's materials that its "trigger did not affect the shut-off mechanism". The authors managed to establish that the valve was just irresponsibly disabled.

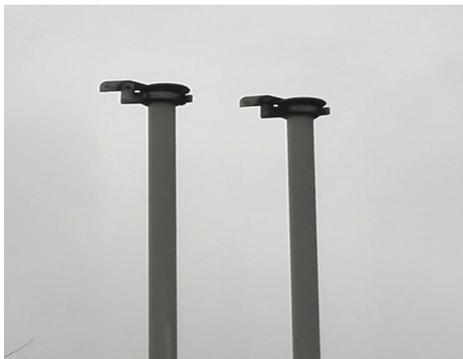
Figure 2. Standard termination of discharge and blowdown pipes at a Polish gas distribution unit plant

It was clear that it was just a half measure. That is why the next step was to structurally prevent moisture penetration in the vent stack. Hinged valves were quickly made at the end of the discharge pipe using materials at hand. The end of the pipe was often cut off at some angle. The valve opened under the pressure of the discharged gas, and after the discharge, it closed under gravity.

This should have made it possible not to make holes for water removal. However, such crude method had unavoidable consequences. Axes of the hinged joints became rusty, and sometimes they jammed, which made it difficult for the valve to open freely. And, which is

worse, a blow of wind could open the valve which further remained open.

Eventually, such devices started to be manufactured in a centralized way at factories (Figure 2). The use of proper materials increased valve reliability but did not rule out the possibility of precipitation penetration in the vent stack. Dirt, feathers, leaves, moisture freezing in a hinged joint — all this can degrade pressure integrity of a closed valve.

Concurrently, a temporary solution was found to prevent accumulation of water in discharge lines (by means of small holes in the horizontal part of the vent stack). In case of rain, water could freely flow through such hole. It should be noted that this was in violation of the principle of preventing explosive gas concentrations from forming in the lower atmospheric layer. The hole was small, but in case of gas discharge, some gas was dumped into the atmosphere at a height of about 0.5 m above the ground level.

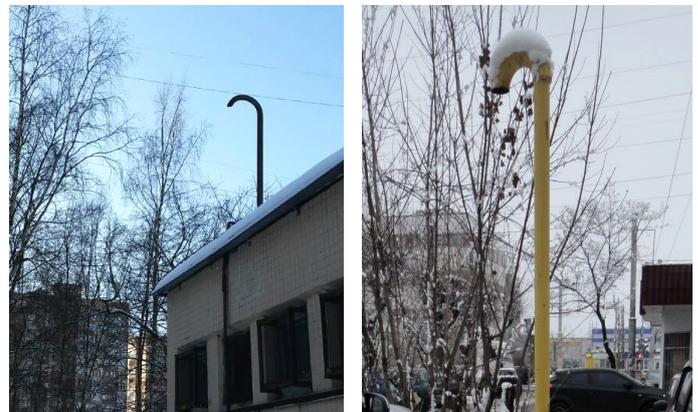
Figure 3. Standard termination of discharge pipes at Russian low-pressure GDPs.

It is not that this way was not considered by the Polish gas supply industry. But the arguments for the solution with a hinged valve look strange. As follows from the explanations by Polish colleagues, they feared that gas outflow at a great speed during discharge could move the area of explosive gas concentration downwards, i.e. to the area of the GDP devices and the working repair crew. It was even assumed that gas flow could gradually wear out the pipe bend.

We will not go into those unreasonable concerns about the pipe "wear". Instead, we will consider a simple example. For a GDP with rated consumption of 60 m³/h with the 25% capacity of the discharge line, the gas outflow rate through the vent stack with a diameter of 25–30 mm would be 5–8 m/s. First, the gas jet that is 1.7 times lighter than air will bend upwards instantly. Besides, together with the rate increase, the ejecting capacity of the jet also increases, and it is diffused and slowed down by air. It is virtually impossible for an explosive gas concentration to form in the lower atmospheric layer at a gas outflow height of 4.5–5 m. Otherwise, this solution could not be used in Russian gas supply.

Any Russian specialist in gas supply would wonder why their Polish colleagues did not think of a simpler and safer solution. We are referring to the bend of the vent stack termination of about 180° downwards, traditionally used at our gas distribution plants (Figure 3). There are no moving parts that could "malfunction". Snow on the bend shown in the photo on the right demonstrates that there is no way for precipitation to penetrate the pipe.
