# CONSTRUCTION METHOD AND APPLICATION OF A BASIC DIGITAL DATABASE FOR THE INTELLIGENT MANAGEMENT AND MAINTENANCE OF EXISTING RAILWAY TUNNELS

**Introduction:** China has an extensive network of tunnels requiring maintenance. An intelligent management and maintenance of these tunnels based on a digital information system can be useful. To this end, it is necessary to collect relevant digital information regarding the tunnel body and surrounding environment for long-term maintenance. **The purpose of the study** was to take an existing operational tunnel as the research subject; this study applied various information technology methods to construct a basic digital database for the intelligent management and maintenance of tunnels. **The following methods** were used: data statistics, drone aerial photography, ground penetrating radar, full-section laser scanning and theoretical analysis. As a **result**, the database can be used as a reference for similar projects.

An existing double-track tunnel with a total length of 5804 m was considered as the research subject in this work. The construction of this tunnel started in 1989 and was completed in 1993. It was operationalized in 1996.

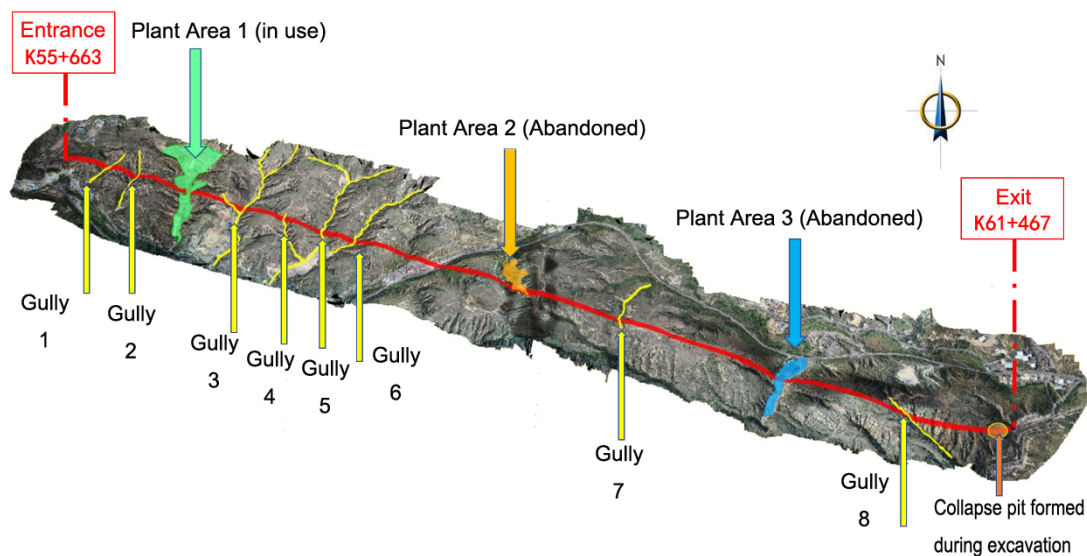
Fig. 2. Distribution of gully landform above the tunnel

A comprehensive aerial photography of the ground surface was conducted within a range of approximately 200 m on both sides of the tunnel centerline using drones. External environmental data were also collected, such as terrain and topography along the tunnel, gullies, nearby factory buildings, underground mining areas, current state of entrances and exits, and burial locations and conditions of auxiliary tunnels. Based on the collected basic image data, the key terrain and topography information within the survey area were modeled and processed. Based on the collected "Tunnel Completion Map" and other drawing materials, as well as the comprehensive external environment of the tunnel collected by drones, on-site surveys were conducted to compare and verify the collected data. Key environmental features, such as important gullies, nearby factories and mines, and tunnel auxiliary tunnels, were investigated and verified (Fig. 2), to discover possible and potential harmful environments. Through a comprehensive comparative analysis, the tunnel structure below the gully was found to be prone to severe water leakage, while the tunnel structure under the factory and mine was prone to more diseases. The internal structure of the auxiliary tunnel was also severely corroded by water leakage.

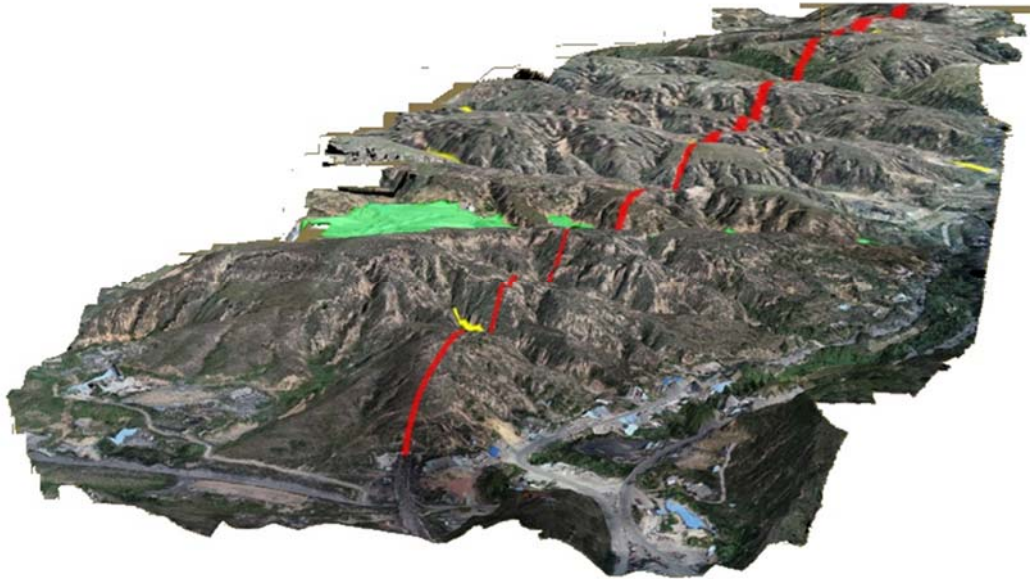
Fig. 3. Skewed 3D model results

width of 400 m on both sides of the tunnel centerline. A skewed model map (Fig. 3), displaying the current state of the tunnel surface from a full perspective, can be used as basic data for regular surface condition collection and terrain comparison measurement. In the later stage, it can be combined with the BIM to serve as basic digital data for relevant early warning systems to timely grasp the changing trends of surface diseases and to expand the digital assets of tunnels (Cheng et al., 2019). A topographic map of the tunnel was constructed as well. By combining the completed plan and longitudinal section, an electronic version of the topographic map and an electronic version of the longitudinal section can be formed.

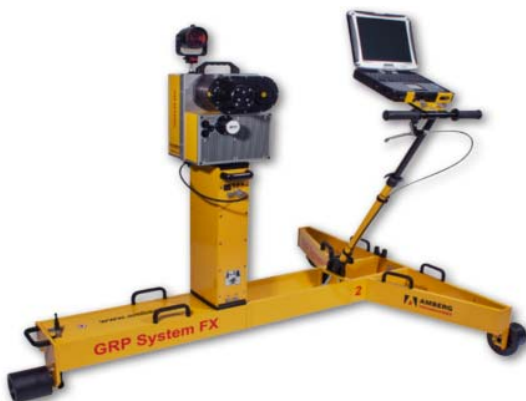
Fig. 4. GRP5000 tunnel scanning system

The GRP5000 tunnel scanning system (Fig. 4), which is currently one of the more advanced tunnel detection technologies, was used for the digital acquisition (Wen et al., 2014). The system meets the requirements of railway tunnel clearance, convergence deformation, and surface disease detection. It integrates a manually pushed rail inspection car and a high-speed laser scanning measurement technology. This makes it suitable to rapidly detect tunnels during tunnel operation, establish digital operation archives, guide maintenance operations, and improve operation and management levels.

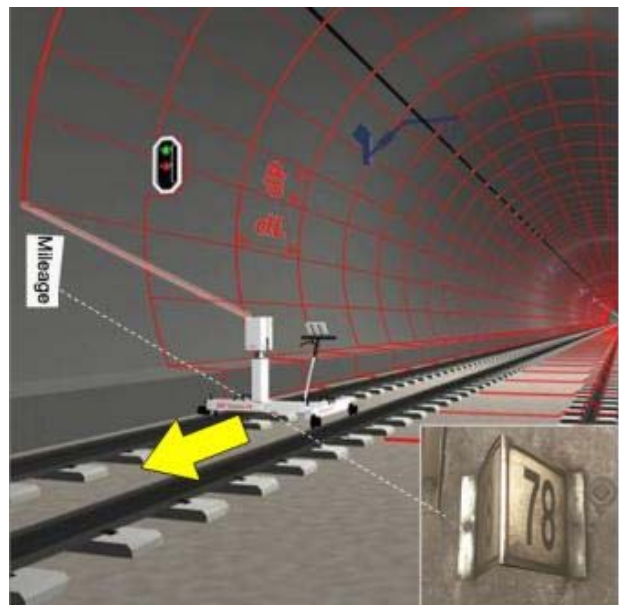
Fig. 5. Schematic of the full-section scanning of a tunnel

A laser scanner was used to perform a full-section high-density scanning of the tunnel in a spiral

shape (Fig. 5). The acquisition software gathers image information of the inner surface of the tunnel lining by analyzing the intensity of the emitted and received laser signals, forming a grayscale image (Fig. 6). By analyzing the phase difference between the emitted and received laser signals, the 2D coordinates of the scanning points on the surface of the tunnel lining can be obtained. Combined with the external absolute positioning of the total station or inertial navigation, the 3D absolute coordinates of all the measurement points can be obtained. The true unfolding map and cross-sectional contour information of the tunnel surface diseases can be

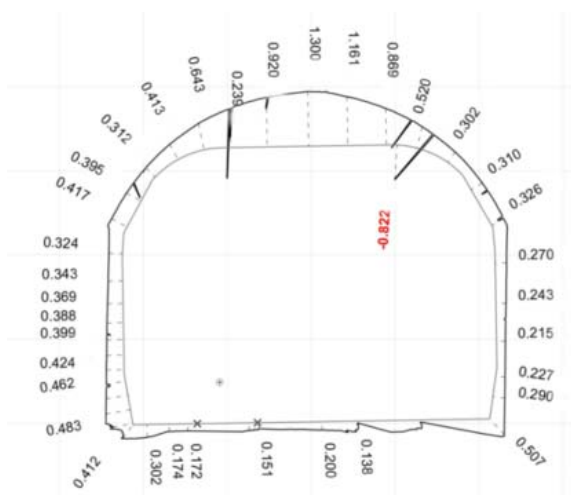
Fig. 7. Cross-sectional view Unit (m)

determined using professional post-processing analysis software (Fig. 7).

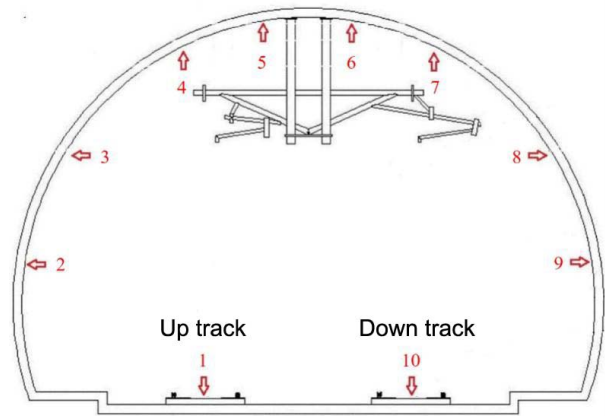
Fig. 8. Schematic of the geological radar

Based on the current internal state of the tunnel, the SIR-3000 geological radar host and a 400 MHz

shielded antenna were used for detection. This radar system host is lightweight, highly automated, has stable signals, high detection speed, and high resolution. It can display the detected profiles in real time, allowing for post-processing and interpretation of the data on a computer, thus integrating the data collection and processing steps. Ten survey lines were set up throughout the tunnel (Fig. 8), including two at the bottom of the tunnel, two on its side walls, and six on the arches. The lining inside the tunnel has a significant amount of fly ash, and the existing facilities and equipment are relatively outdated, and there is a need to avoid more interference. Therefore, the method used in this study was manual small carts (Fig. 9), which can adapt well to the characteristics of the coal transportation line in the tunnel. This method can not only closely adhere to the tunnel wall but also timely avoid old facilities,

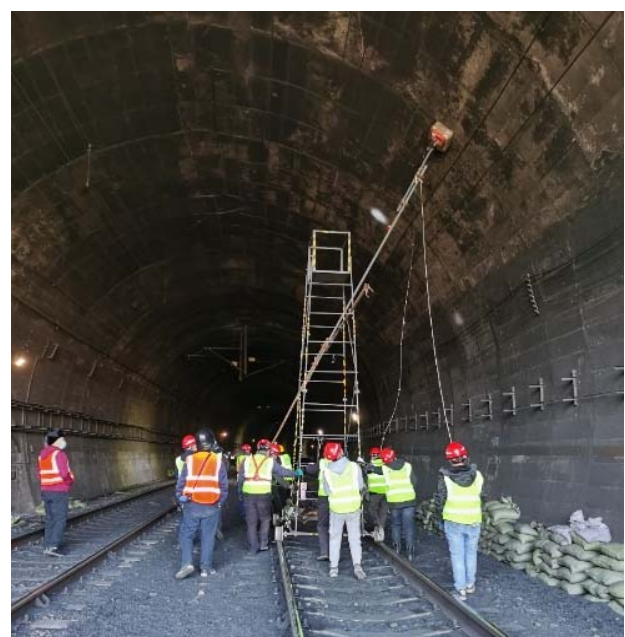
Fig. 9. Ground penetrating radar detection of tunnel lining

and the detected data are accurate and reliable. The detected contents mainly include the thickness of the tunnel secondary lining, void and non-dense distribution inside and behind the secondary lining, cracks and water accumulation on the tunnel floor, and other issues.

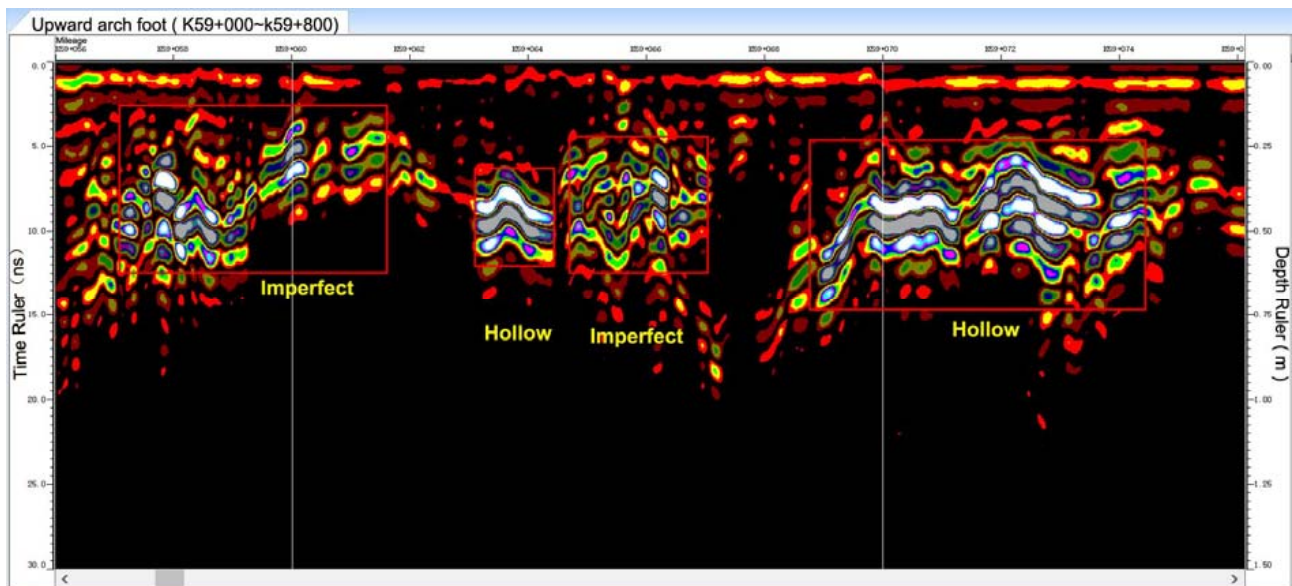
Fig. 10. Typical image of voids and non-compact areas inside (behind) the lining

A set of ground penetrating radar data was obtained, including information related to the position, shape, structure, and size of the detected target body. Clear and interpretable geological radar image profiles were generated through data processing. A search for areas in the radar wave spectrum where the reflection wave has discontinuous in-phase axes produced bending, strong reflection wave energy, and strong echo amplitude response. Based on the phase, frequency, and amplitude changes of the radar waves, a comprehensive qualitative judgment was made, and the density of the backfill (or grouting) behind the lining, the thickness of the lining, and the distribution of steel frames and steel bars inside the lining were ultimately determined.

The digital assets collected include a set of geological radar data, clear and interpretable geological radar image profiles, and typical disease images inside (behind) the lining (Fig. 10).

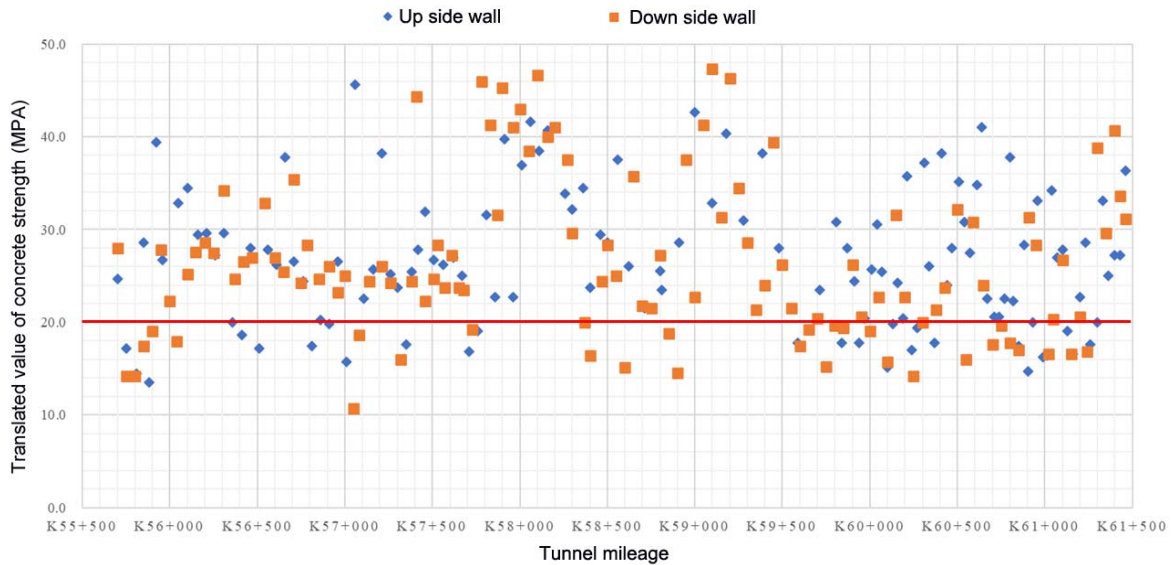
Fig. 11. Distribution of the concrete strength of existing tunnel lining side walls by mileage

A digital collection of the concrete strength data for tunnel lining was performed using a concrete rebound meter for testing. In accordance with the standard, each detection point was located 50 m away, and 234 detection areas were tested along the entire line. By revising, a table of the concrete strength for the entire tunnel was formed, and areas with insufficient concrete strength were identified. A total of 60 tested areas were found to have

insufficient concrete strength (Fig. 11), including 29 upstream side walls and 31 downstream side walls.

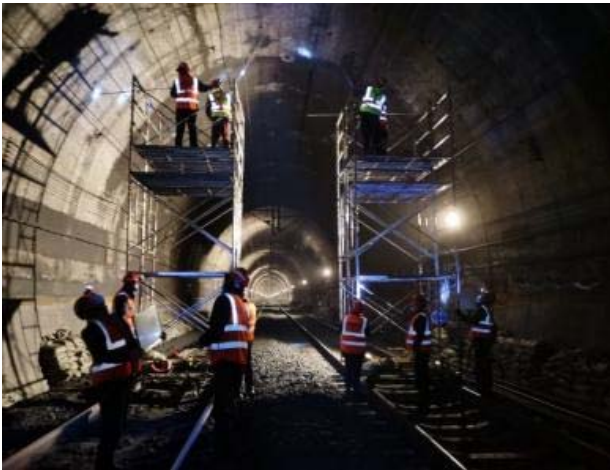
Fig. 12. Tunnel manual tapping detection

(1) Tunnel manual tapping detection technology: The method of manually tapping the tunnel wall (Fig. 12) was used to investigate hidden dangers in the tunnel lining (Bao et al., 2023). The main factors to be investigated include concrete cracks, falling blocks, voids, water leakage, water accumulation in ditches, diseases in car shelters, and mud pouring from the tunnel. The main results are various disease tables, including data on voids and cracks, which are mutually verified with nondestructive testing results. A comparative analysis showed that the results of nondestructive testing and manual testing mostly overlap with each other, proving the high accuracy of the nondestructive testing data in this study.

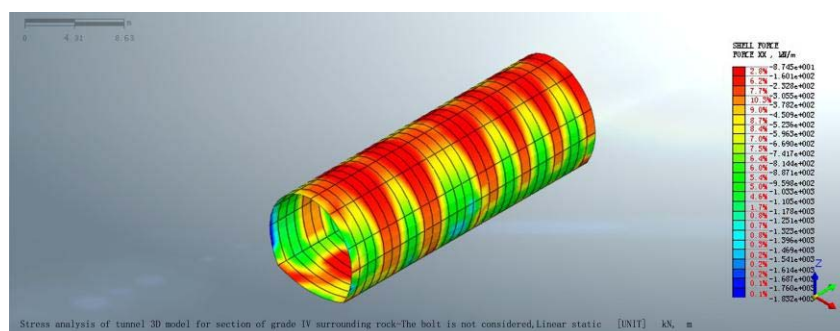
Fig. 13. Modeling results of the stress acting at typical sections of the tunnel lining

were identified, modeling was done with measured data, a numerical simulation analysis was conducted on the tunnel, the trend in the tunnel deterioration was identified, and preparations were made for later operation and maintenance of the tunnel. The MIDAS-GTS software was used in the numerical simulation calculation of this tunnel. Based on all the detection results, 76 typical cross-sections in areas with severe diseases were selected and subjected to 2D and 3D numerical simulations (Fig. 13) to determine the bearing capacity of the tunnel lining and the safety of the tunnel structure, and to analyze and predict the further deterioration trend of the tunnel. After using the load structure method to calculate and analyze the tunnel lining structure with different thicknesses and strengths, it was found that the safety factor at the intersection of the arch and the side walls on both sides did not meet the regulatory requirements in all 76 sections, and the safety factor at the arch crown, arch waist, and arch foot of some sections did not meet the requirements. The calculation results obtained using the geological structure method and the load structure method exhibited consistent trends.
