# STUDY ON WATER LEAKAGE DETECTION AND TREATMENT IN METRO STATION STRUCTURES

**Keywords:** subway, station design, water leakage, comprehensive inspection, grouting repair.

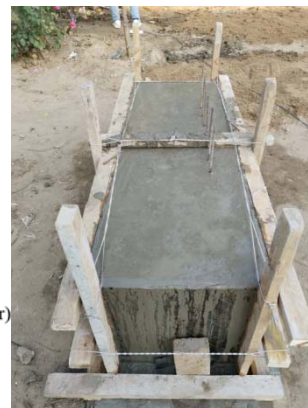
Fig. 2. Schematic diagram of disease location and concrete specimen

In order to simulate the application effect of the detection method and verify the accuracy of the detection results for various types of defects, a concrete block with 0.5 m × 0.5 m × 1.5 m dimensions was made. This block contained an empty bottle, a bottle with water, an earth bag, a stone bag, and linoleum paper to simulate a cavity, water content, slag inclusion, porosity, and cracks, respectively. After the curing of concrete specimens under standard conditions was completed, the detection method was adopted to locate simulated disease. The simulated disease location and concrete specimens are shown in Fig. 2. The internal defects of concrete specimens were detected using

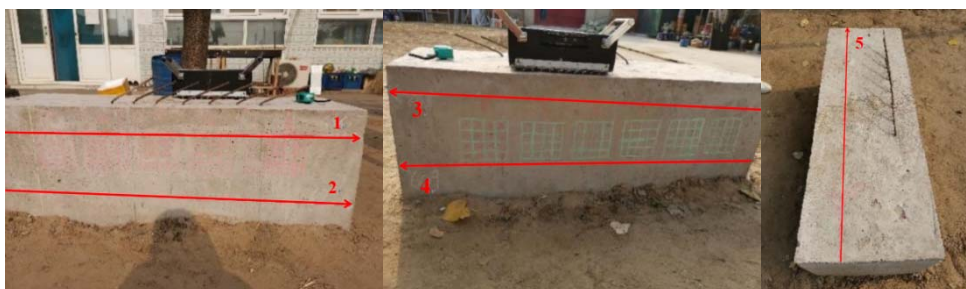
Fig. 3. Survey line arrangement of defects location on concrete specimen

a ground penetrating radar and an ultrasonic 3D scanner. Based on the model size, five radar survey lines were arranged, with two on the front side, two on the back side, and one on the top. The survey line arrangement is shown in Fig. 3.

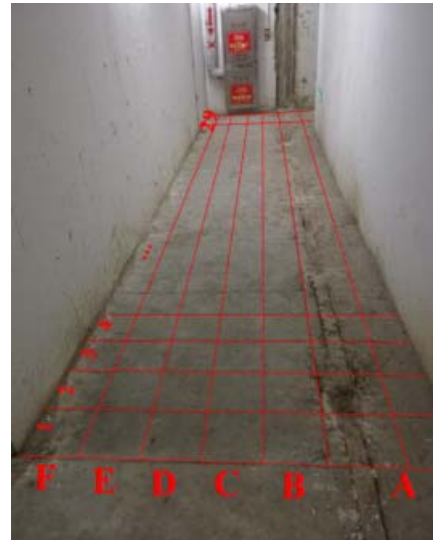
Fig. 6. Layout drawing of the groundwater return condition detection line without a decorative floor

According to the detection method proposed in Table 1, an infrared detector and a water leakage detection instrument were used to detect the leakage point under the condition of groundwater return without a decorative layer. A ground penetrating radar (900 MHz and 400 MHz), an ultrasonic 3D scanner, and a concrete steel bar perspective instrument were used to detect internal defects in the concrete. The detection lines are arranged in a grid of 30cm x 30cm (Fig. 6), the leakage point detection results are shown in Fig. 7, and the results of internal structural defects detection are shown in Fig. 8.

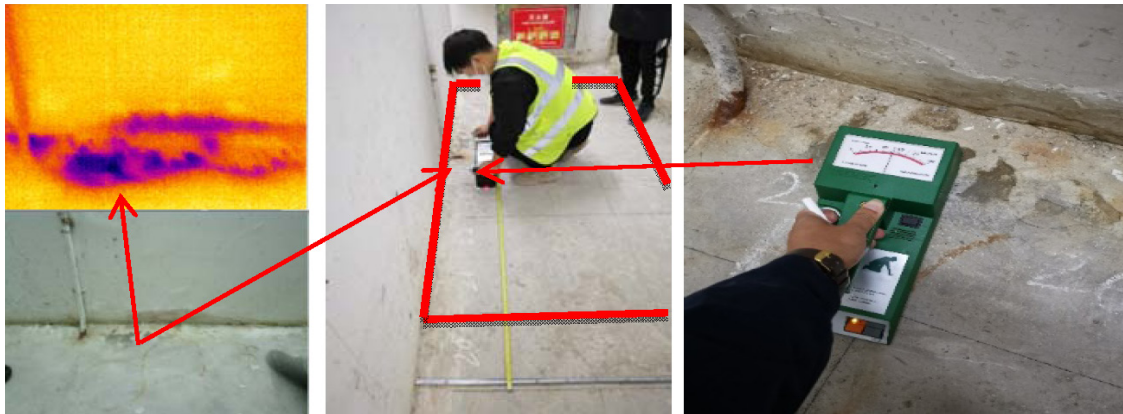
Fig. 7. Results for the groundwater return condition detection line without a decorative floor for leakage point detection

As can be seen from Fig. 7, the blue area in the infrared thermal image represents the area with low temperature abnormalities. The value measured at the same position by the water leakage detection instrument can be inferred as the point of water leakage.

After a comprehensive inspection, both the infrared thermal imager and the leakage water detection instrument detected abnormalities at the same location. This confirms that there is a surface leakage point in that area. Furthermore, the ultrasonic 3D scanner, which has an accuracy of 1 cm, was utilized to identify concrete quality issues

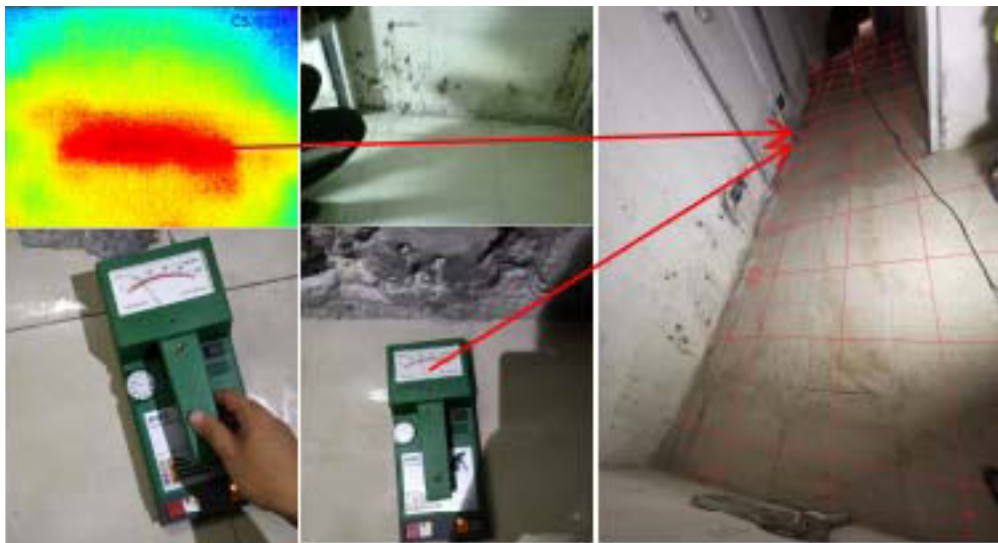
Fig. 9. Leakage point detection results for groundwater return in the wet-sticking decorative layer

As can be seen from Fig. 9, the red area in the infrared thermal image represents the area with high temperature abnormalities. The value measured at the same position by the water leakage detection instrument can be inferred as the point of water leakage. As can be seen from Fig. 10, the ultrasonic 3D scanning map, at the same position

After conducting the combined detection, both the infrared thermal imager and the water leakage detection instrument detected abnormalities at the same location, indicating that this area is the source of surface leakage. Additionally, the ultrasonic 3D scanner, with a precision of 1 cm, was used to identify concrete quality issues at the same spot, confirming the results of the surface detection. Furthermore, the ground penetrating radar also identified an abnormality in this area, with the size of the disease being approximately 1 m in length.

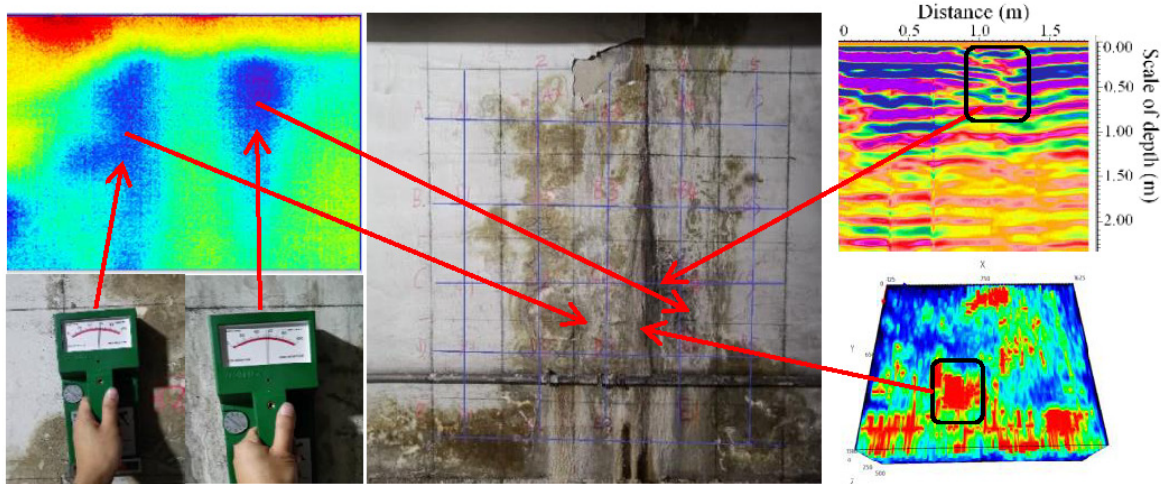
Fig. 12. Results of combined detection of side wall leakage without a decorative layer

The results of identifying leakage points and internal structural defects are displayed in Fig. 12. As shown in Fig. 12, the blue area in the infrared thermal image represents the area with low temperature abnormalities. The water leakage detection instrument reveals a high reading in this area, indicating that it may be the point of surface leakage. Moreover, the blue abnormality area in the ground penetrating radar map denotes a crack,

which is consistent with the actual situation on site. The position highlighted by the black box in the ultrasonic 3D scanning image coincides with the location of the surface leakage point detected by the infrared thermal imager and water leakage detection instrument.

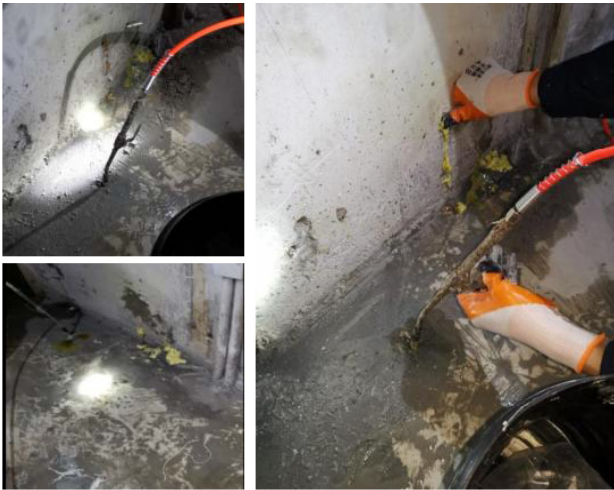
Fig. 17. On-site grouting remediation for groundwater return condition with regard to the wet-sticking decorative layer

Based on the combined detection results for each test point, grouting remediation is carried out at the disease location related to the test point. After grouting remediation, the evaluation of grouting effect mainly includes the following: 1. whether there is still water leakage; 2. geophysical prospecting determines if the leakage path of defects (porosity, cavity, slag inclusion, etc.) is tightly sealed; 3. check the compactness of the grouting through drilling and coring. This paper only offers the grouting remediation solution for groundwater return condition with regard to the wet-sticking decorative layer. Based on the combined detection results, acrylate and modified epoxy resin grouting is performed on the leakage points on the bottom plate surface of the evacuation passageway and in areas with concrete quality issues (leakage paths). The grouting remediation site is shown in Fig. 17, whereas the apparent effect after remediation can be seen in Fig. 18. The ground penetrating radar detection result is displayed in Fig. 19. To ensure more accurate verification of the

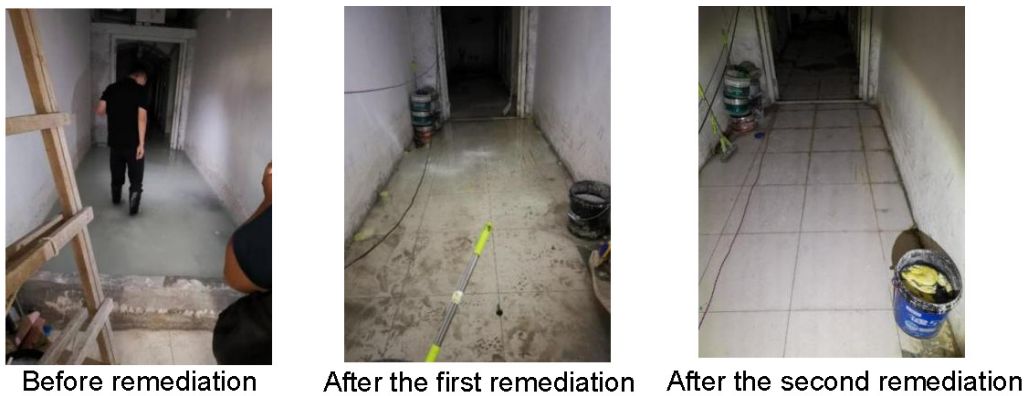
Fig. 18. Apparent effect after remediation for groundwater return condition with regard to the wet-sticking decorative layer

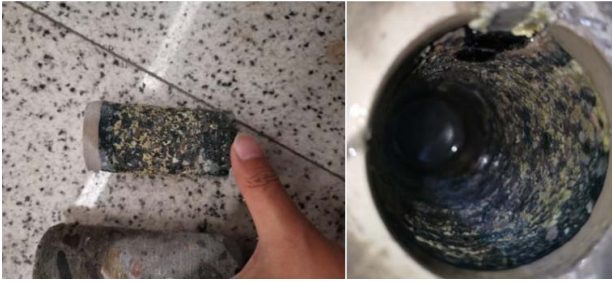
Fig. 20. Borehole coring at B10 after remediation for ground water return condition with regard to the wet-sticking decorative layer

grouting effect, drilling and coring were performed in the B10 area (Fig. 20).
