RESTORATION COMPOUNDS FOR TERRAZZITE PLASTER ON THE EXAMPLE OF CULTURAL HERITAGE SITES OF THE 20TH CENTURY (RUSSIA)

Lyubov Zakrevskaya, Galina Maslova, Elizaveta Repina*

Vladimir State University named after Alexander and Nikolay Stoletovs (VLSU), Vladimir, Russia

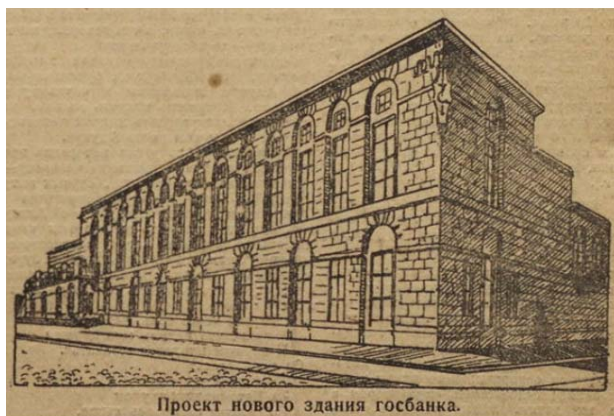
Fig. 1. Fragment of a drawing from the newspaper "Severny Rabochiy", 1929. Design of a new building of the State Bank

The State Bank became the first building of neo-Renaissance constructivism style on Komsomolskaya Street (Fig. 1).

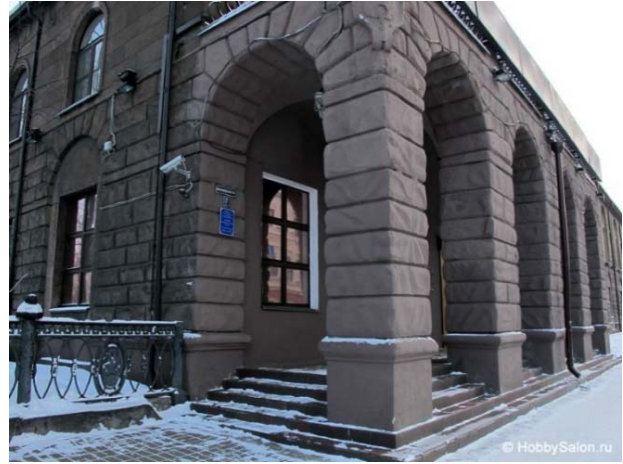
Fig. 2. Fragment of the main facade of the State Bank, Yaroslavl

The main architectural theme was a heavy rusticated wall with widely spaced windows in the style of Florentine architects. The windows were designed as high and rectangular with arched frames in the form of small niches. The only volumetric element of the flat facade was the entrance made in the form of a four-arched portico (Figs. 2, 3).

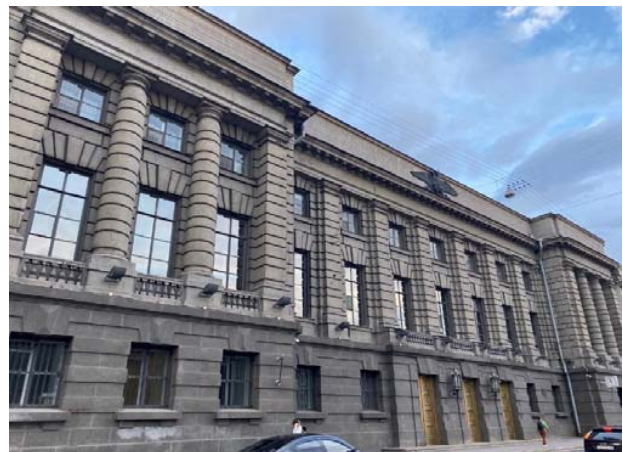
Fig. 4. View of the main facade of the Main Treasury, St. Petersburg

The second site under study is the building of the Main Treasury in St. Petersburg (Fig. 4). The building was designed in the neoclassical style by architects D. M. Iofan and S. S. Serafimov and built by civil engineer S. S. Korvin-Krugovsky in the

period from 1913 to 1915. The building consists of four parts: the main facade building, the central part of the building, and two wings adjacent to the central part on both sides. The central part of the facade building is adorned with decorative pilasters and

columns, and an attic runs above the cornice. The central part of the building is covered with a dome (Chainikova, 2022; Crinson, M. and Williams, 2019; Saifullina, 2014; Šahmenko et al., 2015).

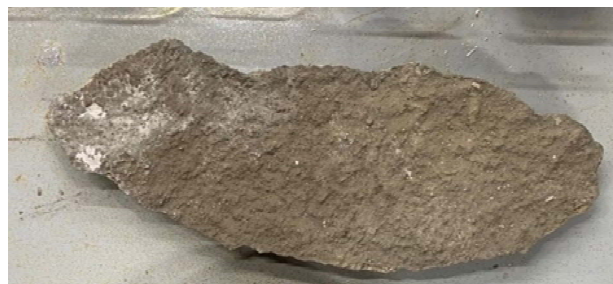
Fig. 6. Sample No. 1 of the plaster of the facade of the Yaroslavl Central Bank building

Fig. 5 indicates the location for sampling the material from the building of the Yaroslavl Central Bank, and Fig. 6 shows a sample of terrazzite plaster on the facade of the said bank.

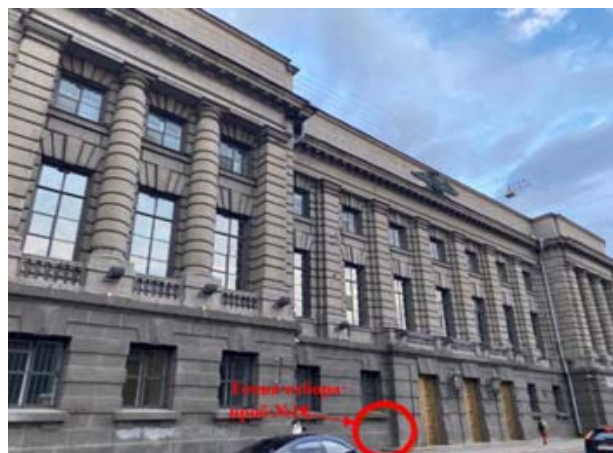
Fig. 7. Location of material sampling from the Main Treasury building in St. Petersburg

Fig. 7 shows the sampling location of the Main Treasury building in St. Petersburg, and Figs. 8–11 show samples of terrazzite plaster of the same facade.

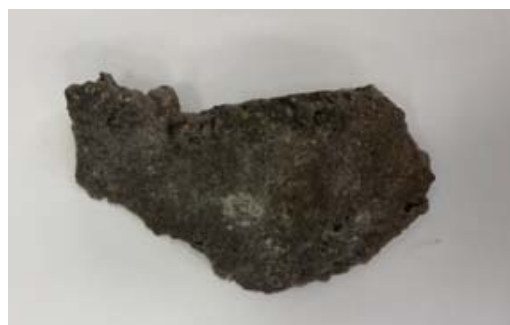
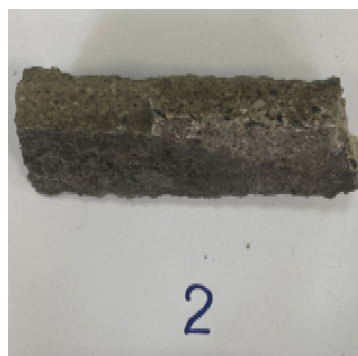
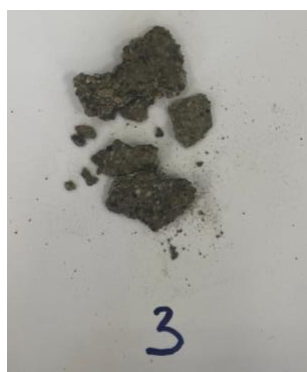
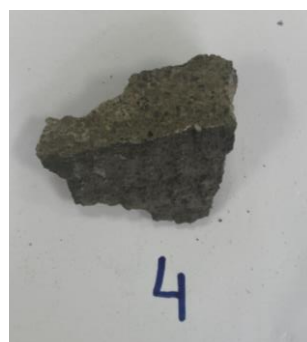
Fig. 8. Sample No. 2 of the plaster of the Main Treasury building in St. Petersburg

Fig. 9. Sample No. 3 of the facade plaster of the Main Treasury building in St. Petersburg

Fig. 10. Sample No. 4 of the facade plaster of the Main Treasury building in St. Petersburg

Fig. 11. Sample No. 5 of the facade plaster of the Main Treasury building in St. Petersburg

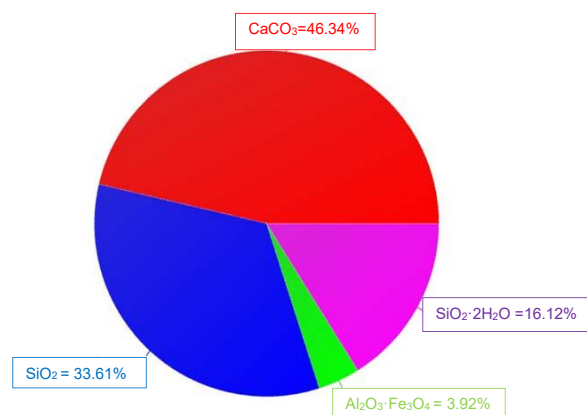
Fig. 12. Results of X-ray phase analysis of sample No. 1 of terrazite plaster on the facade of the Yaroslavl Central Bank building

Fig. 12 shows the results of X-ray phase analysis of sample No. 1 of terrazite plaster on the facade of the Yaroslavl Central Bank building.

The study of the SEM microstructure and X-ray phase analysis of the presented terrazzite plaster samples allows us to conclude that at the research site during construction, as well as during further

reconstruction of the building, the composition used contained lime, dolomite, sand and clay as the main components.
