## EFFECTS OF ENVIRONMENTS CONTAMINATED WITH CHLORIDES AND SULFATES ON RC COLUMNS

### Abstract

**Introduction:** Corrosion of steel reinforcement is a very complex process with clear differences in each geographical location. Many research models predicting the quality deterioration of reinforced concrete structures in areas contaminated with chlorides and sulfates are being developed around the world. However, these models still have a fairly wide application range and fail to accurately and fully reflect the reduction in structure quality in each specific condition. The **purpose of the study** was to survey the current status of reinforced concrete (RC) structures located in chloride- and sulfate-contaminated environments in coastal areas of Vietnam, analyze the result and compare it with previously researched proposals to clarify the impact of corroded steel reinforcement on the quality of RC columns. The following **methods** were used: Experimental Survey, Non-Destructive Testing, and Empirical Formula for determination of the deterioration of parameters including compressive strength of concrete, thickness of protective layer, diameter of reinforcement, and cross-sectional

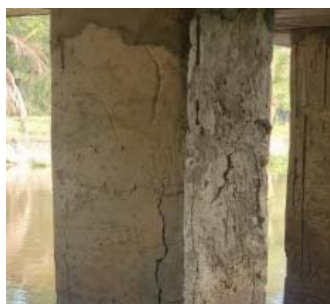
a) Cracks along the protective layer

Fig. 1a shows cracks along the concrete cover / protective layer of what appears to be a reinforced concrete column or a structural member. The cracks seem to be running parallel to the reinforcing bars within the concrete, suggesting that the cracking may be related to reinforcement corrosion and expansion.

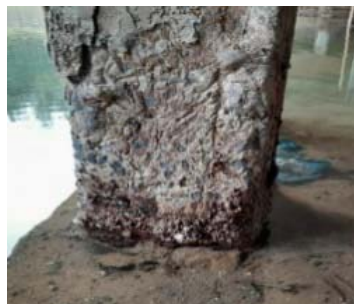
b) Decreased cross-section area

In Fig. 1b, the cross-section reveals a decrease in the effective area of the concrete due to cracking, spalling, and potential loss of concrete cover. This reduction in the cross-sectional area can lead to a loss of structural capacity and compromise the strength and durability of the member.

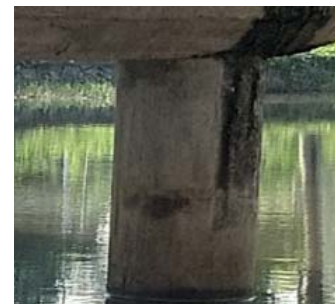
c) Rusty reinforcement revealed

Fig. 1c shows the revealed and corroded reinforcing bars within the concrete member. The reinforcement appears to be heavily rusted and corroded, indicating advanced deterioration due to factors such as chloride ingress or carbonation. The loss of concrete cover has exposed the reinforcement, making it vulnerable to further corrosion and potentially leading to a loss of the bond between the steel and concrete.

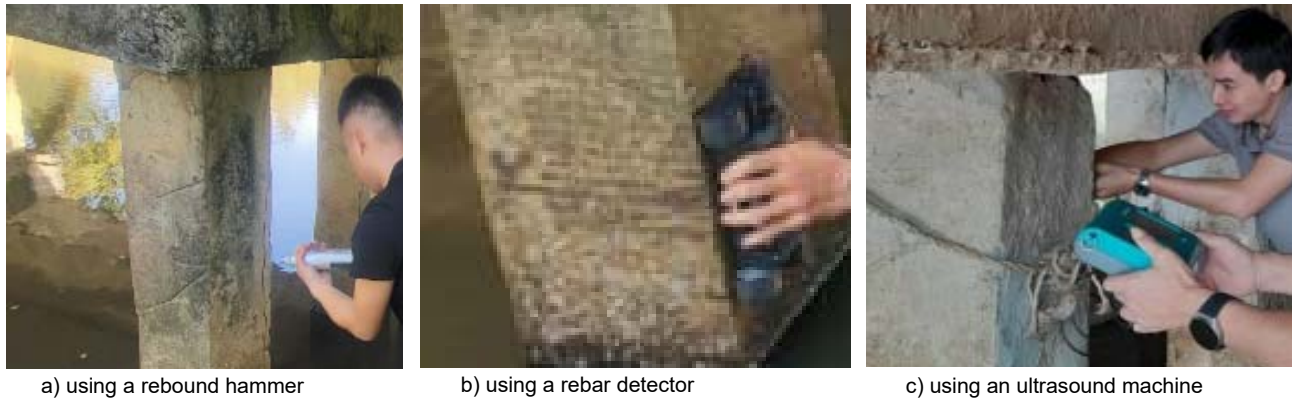
Fig. 3. Equipment used in actual surveys

The survey was carried out on the basis of determining the thickness of the protective concrete layer, diameter of reinforcement, and compressive strength of concrete on RC bridge column components at different sections. The equipment used included a rebound hammer (Fig. 3a), a rebar detector PROCEQ PM-650 (Fig. 3b), and a concrete ultrasonic machine (Fig. 3c). The field investigation results are presented in Table 2.
