ISSUES OF DETERMINING THE RESOURCE OF BEARING CAPACITY OF ANCIENT TIMBER STRUCTURES ELEMENTS

Abstract

Keywords: resource of bearing capacity; ancient timber structures; long-term strength; physical wear; geometric nonlinearity; physical nonlinearity.

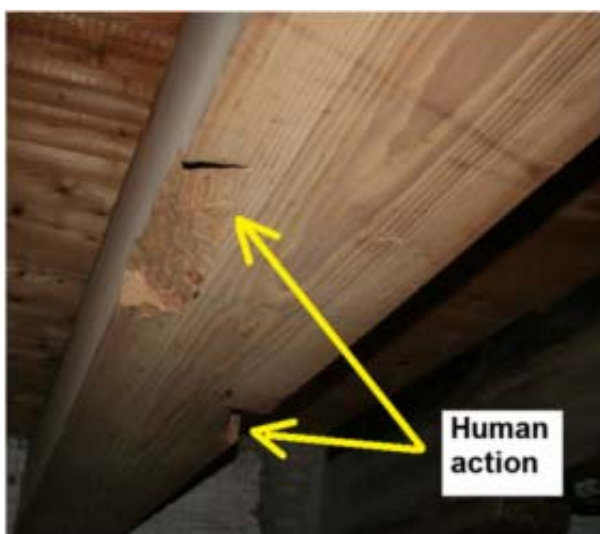
Fig. 2. Mechanical damage (Cabaleiro and Riveiro, 2016)

In the case of historical buildings, due to fiber delamination in timber structures, human activity during operation is more likely to cause section damage (Fig. 2) or fiber cracking due to temperature-humidity fluctuations (Fig. 3), directly reducing the strength, stiffness, and bending capacity of the structure. To assess the bearing capacity of such structures, the concept of effective cross-section is applied, representing the part of the original section capable of withstanding loads. The effective section accounts for degradation zones and excludes damaged areas. For square sections, the maximum permissible value for edge or end delamination is one-third, and for buildings with increased safety requirements, this value is reduced with the introduction of an additional deformation coefficient (Nocetti et al., 2021).

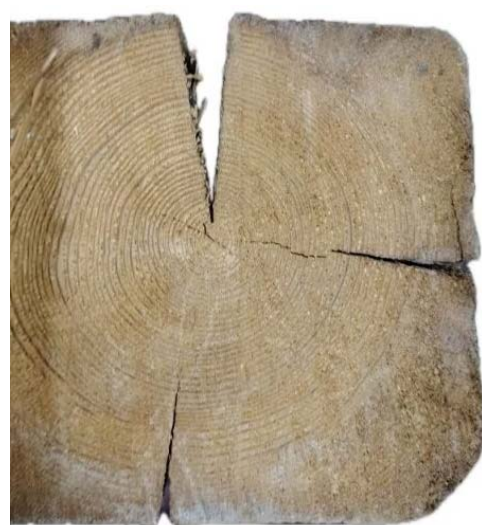
Fig. 3. Fiber cracks
