## HOUSEHOLD BUILDING (LATE 17TH–19TH CENTURY, RYAZAN KREMLIN) RESTORATION AND ADAPTATION TO MODERN USE

Marina Knyazeva<sup>1</sup>, Sergey Mokhovikov<sup>1,2</sup>, Lidia Alekseenko<sup>1</sup>, Natalya Bryazgunova<sup>1\*</sup>

<sup>1</sup>Ryazan Institute (branch) of Moscow Polytechnic University  
Pravo-Lybedskaya St., 26/53 Ryazan, Russia

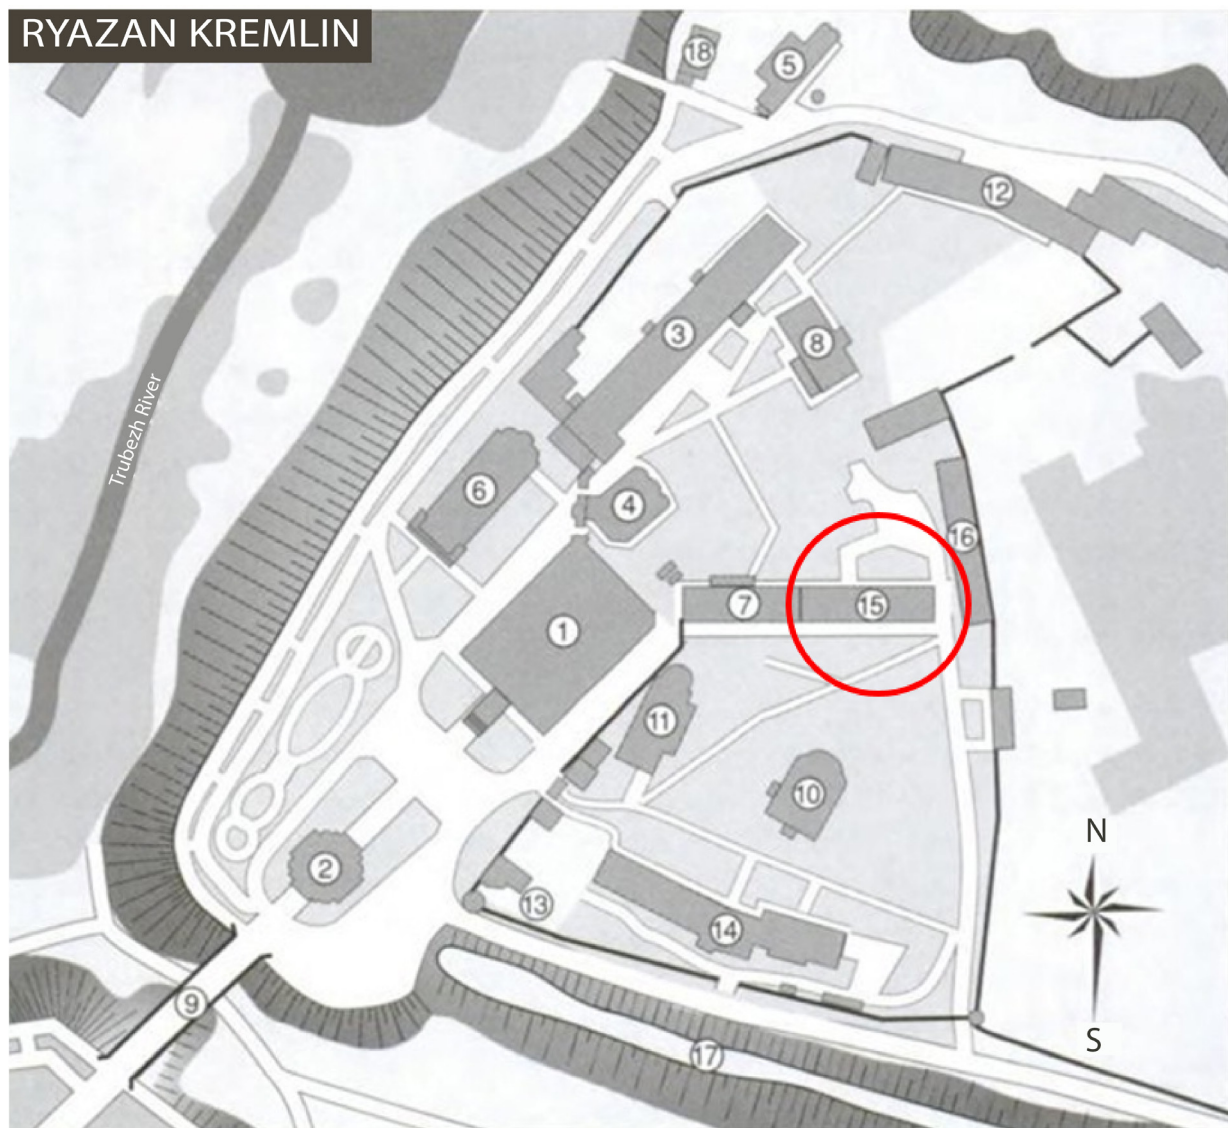
Figure 1. Buildings of the Ryazan Kremlin

1 — the Assumption Cathedral; 2 — the bell tower; 3 — the Bishop's House; 4 — the Cathedral of the Archangel; 5 — the Church of the Holy Spirit; 6 — the Nativity of Christ Cathedral; 7 — the Consistory Corps; 8 — the Singing Corps; 9 — Glebovsky Bridge; 10 — the Cathedral of the Transfiguration of the Savior; 11 — the Church of the Epiphany; 12 — the hotel for monks; 13 — the walls and towers of the Monastery of Our Savior (Spassky Monastery); 14 — the hotel for the nobility; 15 — the household building; 16 — the stables; 17 — the rampart; 18 — the clergy house

The Household Building (late 17<sup>th</sup> century, 19<sup>th</sup> century), a recognized cultural heritage site, is located in the south-east of the Kremlin Ensemble (13<sup>th</sup>–15<sup>th</sup> centuries, 16<sup>th</sup>–20<sup>th</sup> centuries) historical monument of federal significance and was built near the side wall of the Consistory Corps at the end of the 17<sup>th</sup> century and consisted of three units with different functions: a cooper's shop, a blacksmith's shop, and "sheds for various goods". Initially, the units were not connected, and each had an individual entrance from the courtyard (Kolesnikova, 2012) (Figure 1).

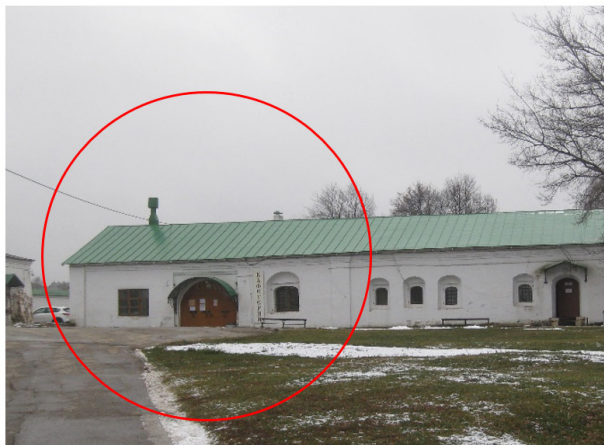
Figure 2. Household Building (late 17<sup>th</sup> century, 19<sup>th</sup> century), current state. Photo, 2021

In the 19<sup>th</sup> and 20<sup>th</sup> centuries, it was rebuilt to become a residential building. Following the restoration of 1970, the exterior of the architectural monument underwent some changes. The large arched gates were converted into windows. Three new window openings were made in the south blind wall. The building was converted into an office of a historical-and-architectural museum-reserve and then — a boiler room (its latest function) (Figure 2).

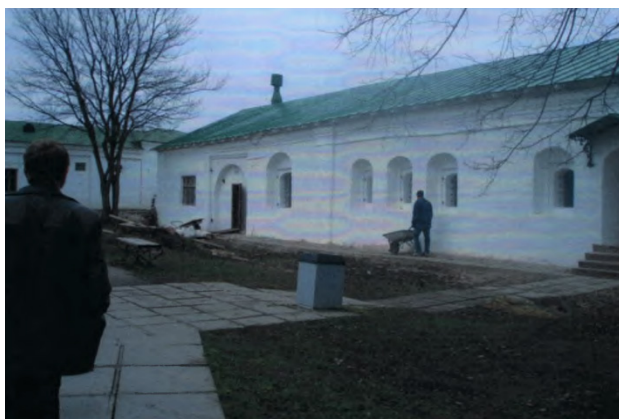
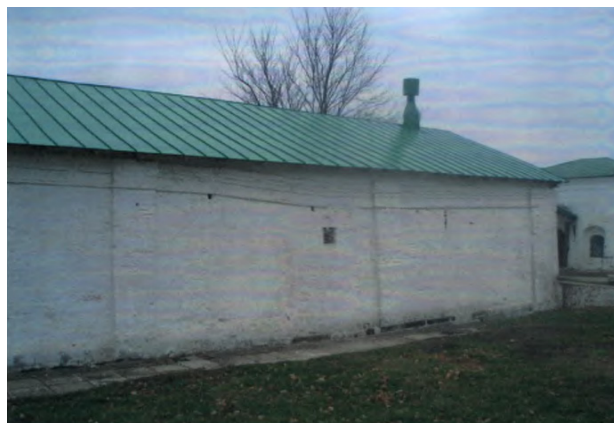
Figure 3. Facades of the building. Photos, 2010

visual inspection of the building was performed and its photos and measurements were taken (Figures 3, 4, 5).

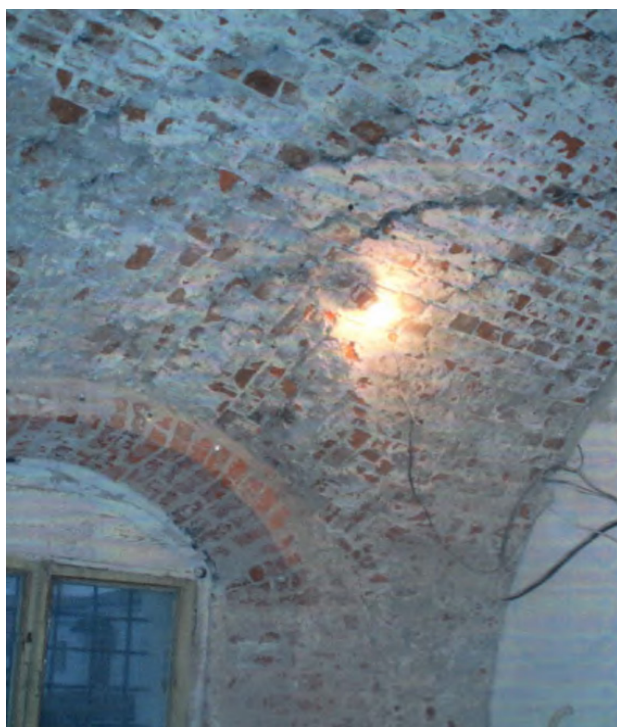
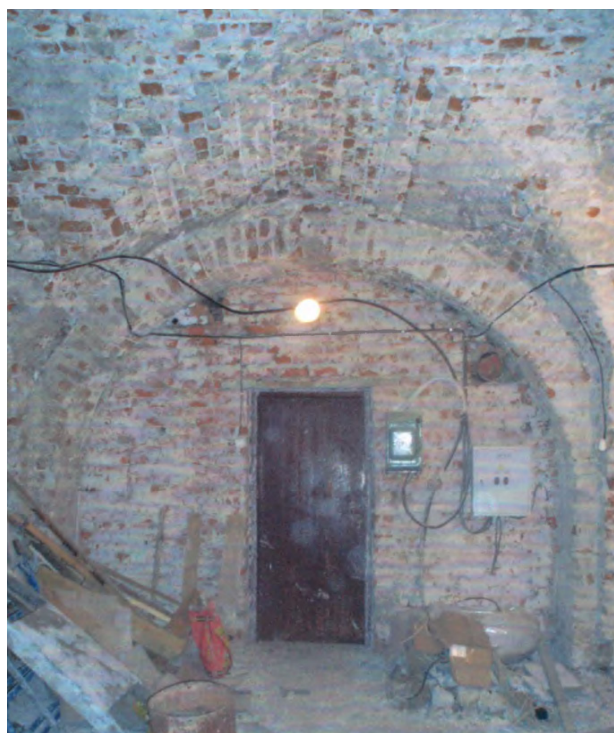
Figure 4. Condition of the interior walls. Photos, 2010

At the time of design documentation compilation, the walls and ceilings had no interior decoration. The floors are lost. The technical condition of the building was determined as satisfactory.

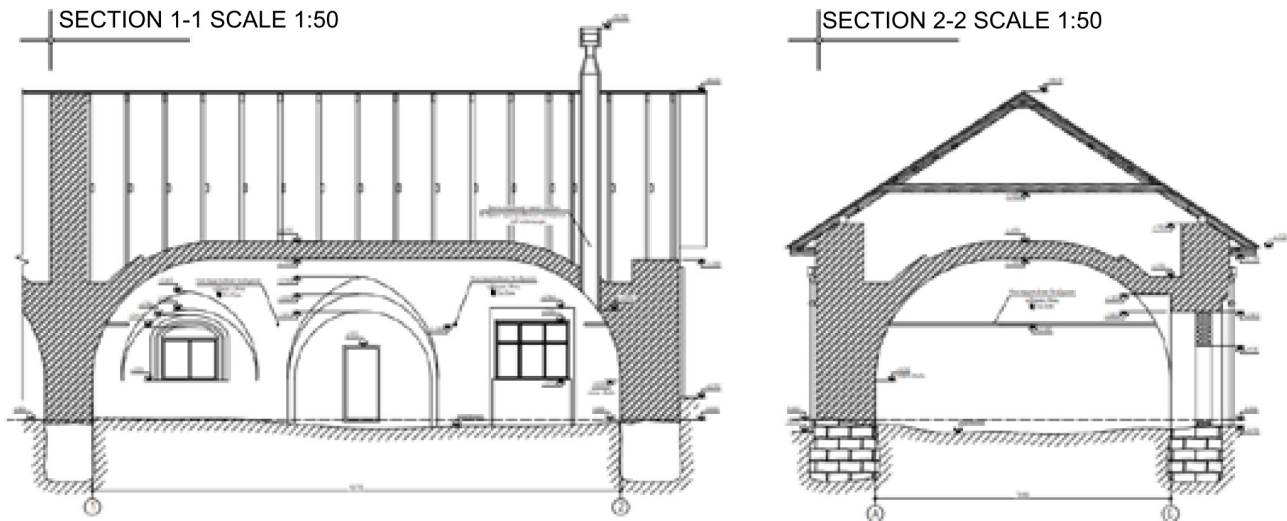
Figure 5. Measurements of the building

The Household Building (late 17<sup>th</sup> century, 19<sup>th</sup> century) is a one-story structure, rectangular in plan, with a gable roof, stretching from north-west to south-east. The exterior walls are made of oversize solid clay bricks. The foundations are strip, made of rubble masonry. The window and door openings are wooden.

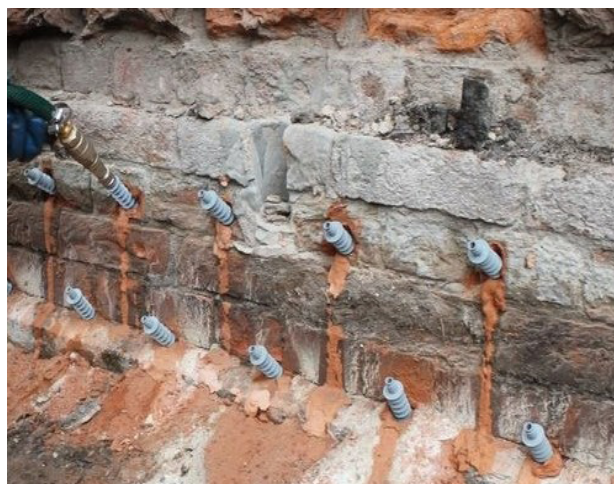
Figure 6. Masonry injection

To restore the lost bond and ensure masonry grouting, increase the structural strength and load-bearing capacity of the external walls and brick vault, masonry injection was used (Figure 6).

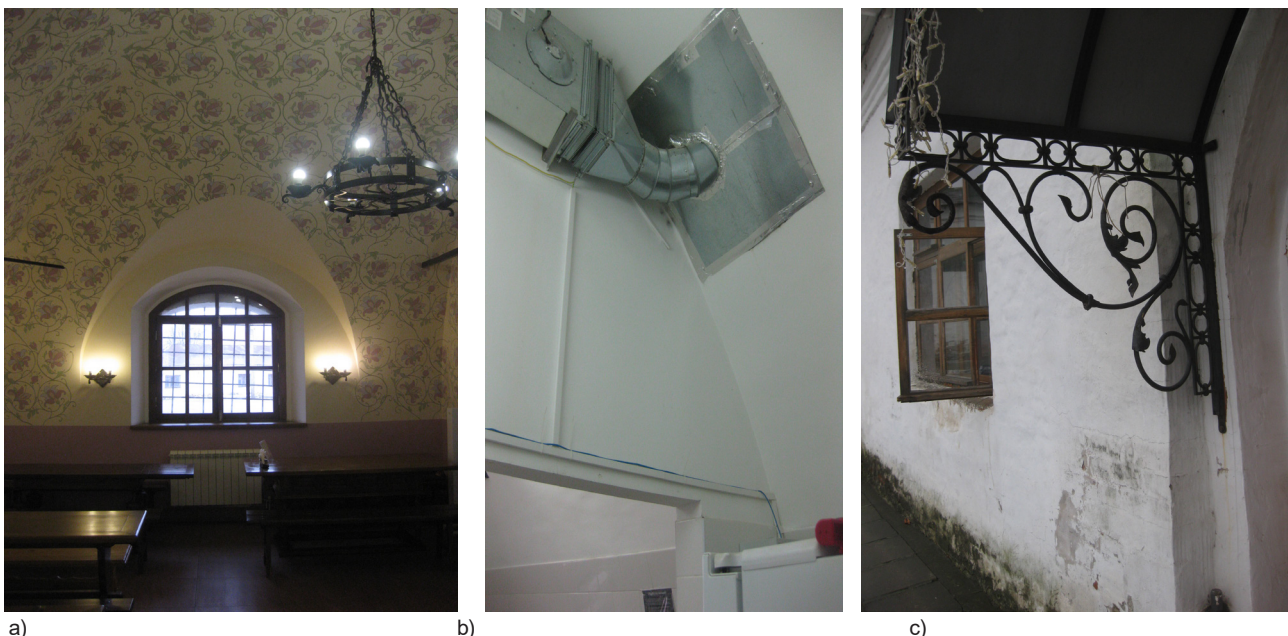
Figure 7. Household Building (late 17<sup>th</sup> century, 19<sup>th</sup> century). Current state. November 19, 2021  
a — the interior of the dining room, b — the ventilation duct, c — the canopy

Therefore, the floors in the cafe were supposed to be tiled as follows, depending on the purpose of the premises: ceramic granite stylized as natural stone (Figure 7a) in the dining room, and standard ceramic granite in the service areas.

Since the building does not have a vent line, ventilation was maintained through galvanized air ducts with an outlet to the roof through a hole in the ceiling (Figure 7b).

The porch has a canopy with forged brackets (Figure 7c).
