NON-DESTRUCTIVE MONITORING AND TECHNICAL EVALUATION CONDITIONS OF THE MONUMENT ALEXANDER III

The article presents the methods of non-destructive testing and evaluation of monuments of cultural heritage, verified by the example of technical analysis of the structure and the defective condition of the monument to Alexander III (St. Petersburg). The methodology includes a set of scientific and technical activities and consists of several blocks of analysis of the composition of materials and design features: visual-optical, capillary, acoustic-ultrasonic, acoustic-ultrasonic pulsed, thermal-imaging, X-ray fluorescence and metallographic.

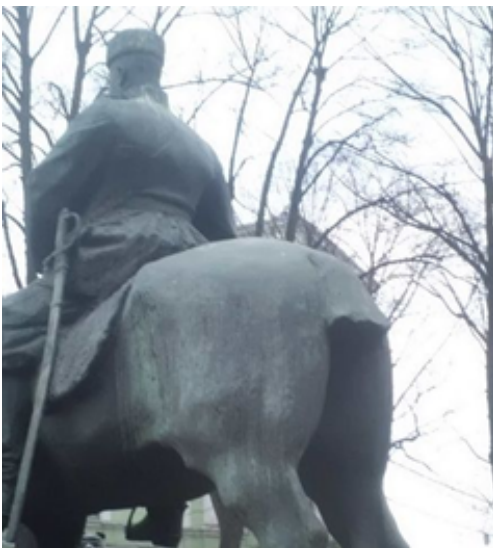
The use of the endoscope allowed examining in detail the condition of bolted connections in the horse's belly. The advantage of the endoscope is the presence of an operator-controlled head equipped with a magnifying lens, so the place of control is examined in an enlarged form and even minor defects are detected.

This allowed us to verify the good quality of bolt connections. It should be noted that the advantage of the endoscope is at the same time its disadvantage as the use of a microlens leads to the fact that the field of view and depth of field are very small, so the method is

Figure 4. The scheme of elements of the monument to Emperor Alexander III – the back part of the horse.

very laborious and tedious for the operator. The method, in such an implementation, can only be recommended for surveying individual sites. Otherwise, television endoscopes should be used.
