THE 30TH OF OCTOBER SAMOS-GREECE EARTHQUAKE. ISSUES RELEVANT TO THE PROTECTION FROM STRUCTURAL DAMAGE CAUSED BY STRONG EARTHQUAKE GROUND MOTIONS

George C. Manos
Editor in Chief
Professor Emeritus, Aristotle University of Thessaloniki
Thessaloniki, Greece

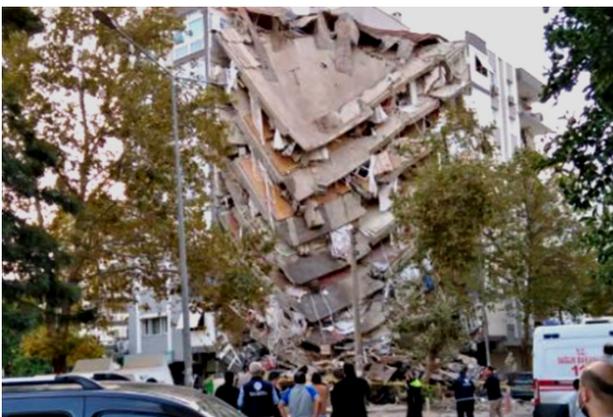
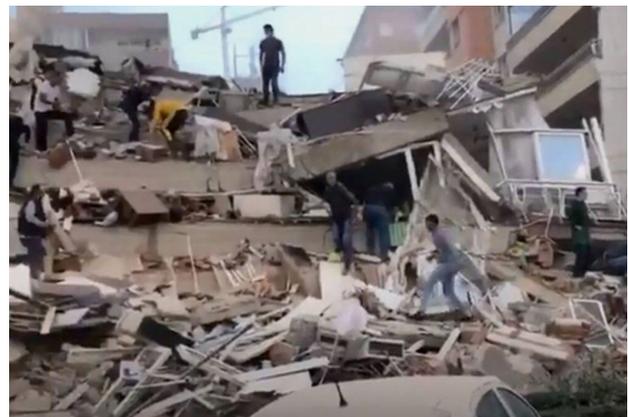
Figure 7. One of the many collapsed multistory buildings at Izmir-Turkey

As already mentioned, in contrast to the collapsed multi-story buildings at Izmir-Turkey (Figure 7), fortunately very few reinforced concrete buildings in Samos Island sustained structural damage. Figure 8 depicts such a case of damaged columns at the ground floor of a RC multi story building. This particular structural deficiency of a “relatively” flexible ground floor for RC multi-story buildings in Greece has been identified for some-time (see Manos, 2011) This is due to the fact that the shear force demands at this level are amplified because of the increased stiffness of the upper floors, which is not accounted for in design that ignores the influence of well-built masonry infill in these upper floors. Moreover, the old design provisions did not focus on shear reinforcing detailing of these ground floor columns to provide for sufficient shear strength to meet such shear amplified demands.

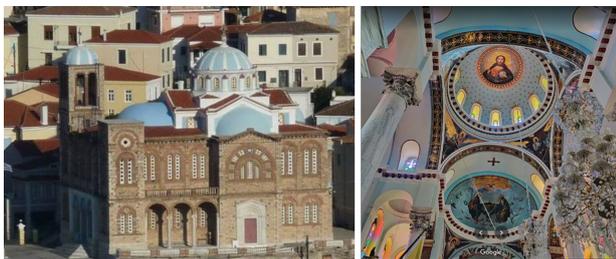
Figure 9. The church of Koimiseos Tis Theotokou (Assumption of Virgin Mary) in Karlovasi the Cathedral church of Samos, prior to the 30th of October 2020 earthquake

2. The seismic resistance of these walls is reduced by the openings (doors or windows) as well as by the way they are constructed in terms of materials and construction techniques. Figures 9 and 10 indicate that these are constructed with unreinforced masonry. An extensive research of the structural damage of unreinforced masonry peripheral walls forming numerous churches at the Greek island of Kefalonia is described in summary form in references (Manos and Kozikopoulos, 2015; Manos, Kotoulas and Kozikopoulos, 2019; Manos and Kotoulas, 2019). This investigation combined the results of 3-D numerical simulations and assumed failure criteria to demonstrate the validity of utilizing realistic limit-state scenarios in order to explain successfully the observed damage. These limit-state scenarios include mainly shear or diagonal in-plane modes of failure or out-of-plane bending modes of failure. Such typical damage is depicted in figure 15.

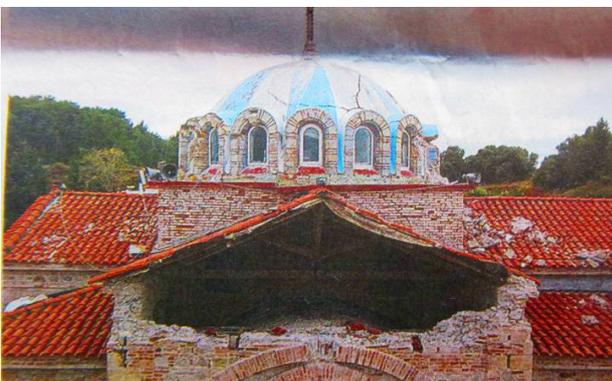
Figure 13. The church of Virgin Mary at the village of Konteika Samos island built in the 19th century. This church is again of the cruciform typology with a central spherical dome that sustained structural damage of the peripheral wall of typical morphology (Manos, Soulis, Diagouma, 2008)

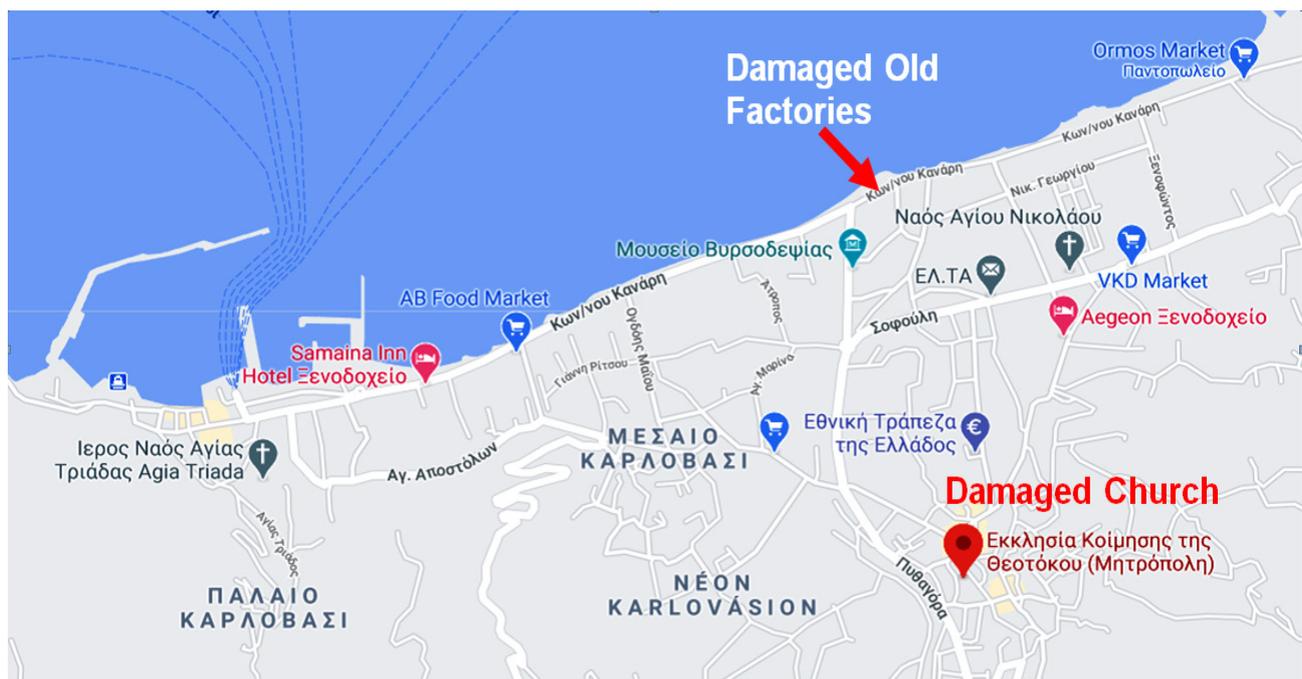
as shown in figure 22. The observed damage was of the typical form of loss of support and collapse of the wooden roof accompanied by the partial out-of-plane collapse of the long peripheral walls. The location of these buildings is shown in figure 21.

Figure 21. Map indicating the location of the damaged old industrial buildings in Karlovasi - Samos

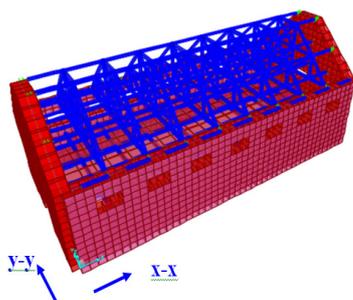
Figure 26. The numerical model of a typical industrial building of unreinforced masonry damaged by the 30th of October Samos earthquake (see figures 19 and 20)

The numerical model of this analysed industrial building with its wooden roof is depicted in figure 26. The wooden roof elements are connected with the masonry peripheral walls without transferring any bending moments. The stiffness of this connection is a parameter that is varied in this investigation. Summary results from various numerical dynamic spectral analyses are presented here. Each dynamic analysis is carried out based on the response spectral curves derived from the recording of the earthquake motion in the two horizontal directions at Vathi (Fig. 25). It was discussed, that this represents a realistic assumption. The corresponding spectral curves are depicted in figure 27. The response spectral curves in these figures were derived assuming a behaviour factor value equal to $q=1.5$ that is appropriate for unreinforced masonry structures.

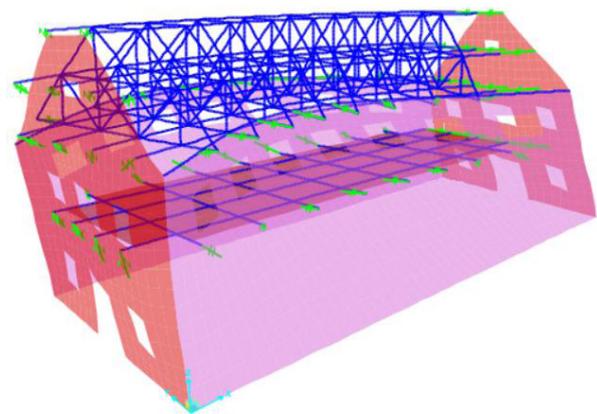
The two-fundamental translational eigen-modes, derived from this numerical model, are depicted in figures 28 and 29. Figure 28 depicts the 1st translational mode in the direction y-y. The outstanding response in this mode is the out-of-plane response of the two longitudinal peripheral walls parallel to the x-x axis. Similarly, figure 29 depicts the 2nd translational mode in the direction x-x. The outstanding response in this mode is the out of plane response of the peripheral walls parallel to the y-y axis. The eigen-period values of these 1st and 2nd translational modes are shown in figure 27 depicting the response spectral curves in the N42E and N48W horizontal directions, respectively. A range of such eigen-period values are plotted in these two plots. The variation of these eigen-period values resulted from the variation of the stiffness of the connection of the wooden roof elements to the masonry peripheral walls, as indicated in these plots.

Figure 28. 1st translational eigen-mode. Out of plane response of the peripheral walls parallel to the y-y axis

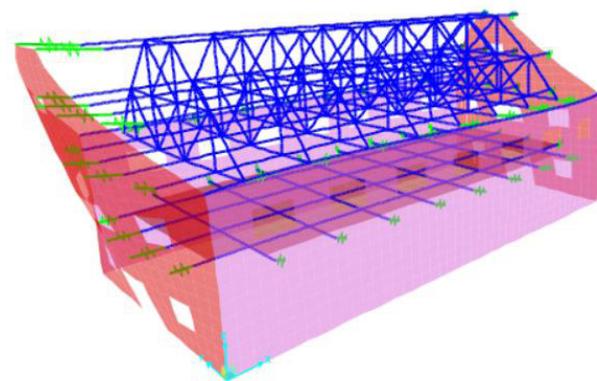
Figure 29. 2nd translational eigen-mode. Out of plane response of the peripheral walls parallel to the x-x axis
