## DISMANTLING AND RECONSTITUTION OF PRASAT SUOR PRAT, ANGKOR THOM, CAMBODIA

### Abstract

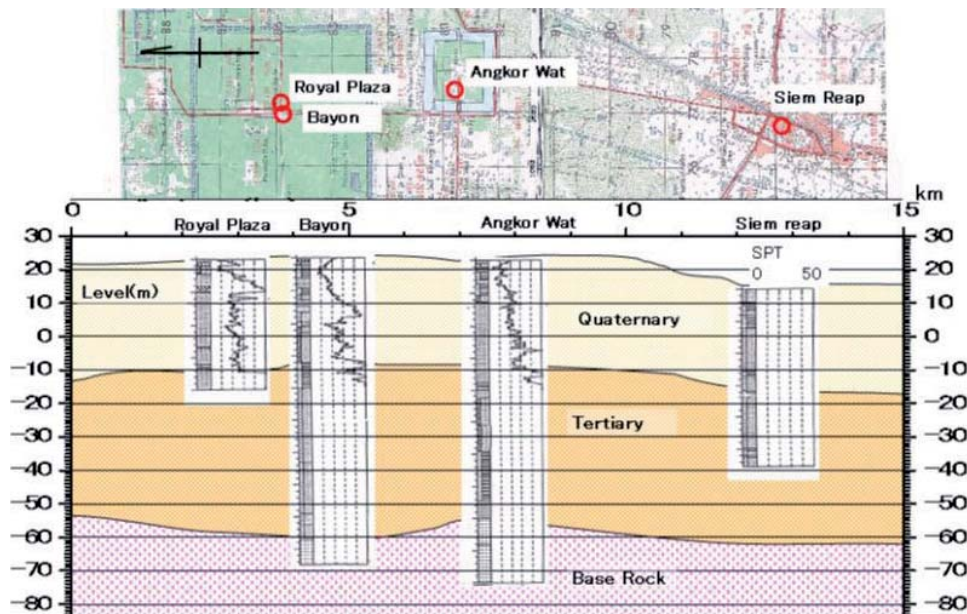
Fig.3. Geotechnical Section along N-S section from Bayon, Angkor Wat, to SiemReap

Fig.3 shows a north-south section of the boring logs at the Royal Plaza, Bayon in Angkor Thom, Angkor Wat, and Siem Reap city. The upper 40m of the ground surface is Quaternary deposits of silty fine sand with several clayey rich layers. In general SPT (standard penetration Test) N-value increases with depth except at the top surface. N-value at the top surface is 20 and decreases to 10 at the depth of 5m. The boring at this point was carried out in March 1995 of dry season. The cone penetration test that was performed in rainy season at the same site revealed that the cone resistance decreased to

zero at the surface and increased with depth down to about 5m. The top surface of 5m is affected by the seasonal change of water level.

Water condition in the ground gives crucial effects upon mechanical characteristics of surface ground in Angkor and forms one of the characteristic elements of cultural heritage.

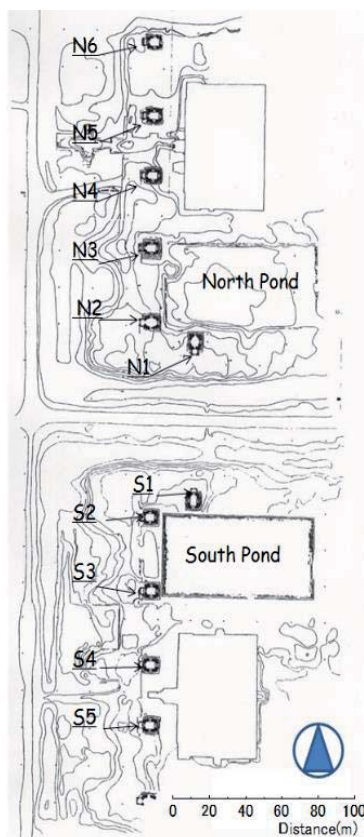
Fig.4. 12 towers of Prasat Suor Prat

Prasat Suor Prat (Tower of Rope Dancer) is a group of 12 independent towers along the west side in the Royal Plaza as shown in Photo-1 and in Fig.4 of plan view. These towers are divided into two groups of North and South. The inclination of side walls for all the towers at Prasat Suor Prat were measured and listed in Table1 and shown in Fig.5. Inclinations of the towers are less than 2-4 degrees except N1 and S1 and with direction of NW to NE. N1 and S1 show the largest inclination among each

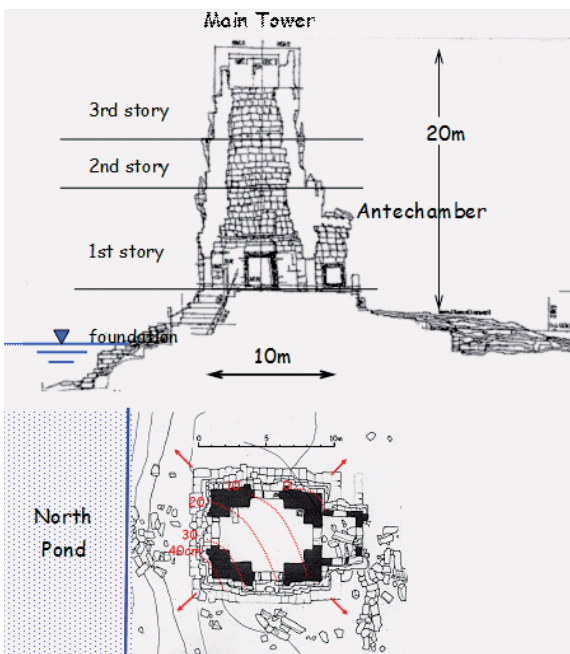
Fig.6 Vertical section and plan for N1 Tower

One of the 12 towers named as N1 that had been inclined about 5degrees northwards was selected by JSA for safeguarding work as shown in Photo 2. The tower consists from a main tower with a front room called antechamber. The main tower is three story masonry structure with laterite bricks with 10m in width at foundation and about 20m in height. The inside of the tower is hollow structure with four open windows at every wall. Fig.6 shows vertical section and plan view of the N1 tower nearby the north pond.

The differential settlement of the foundation was measured about 40cm at the north and west corner

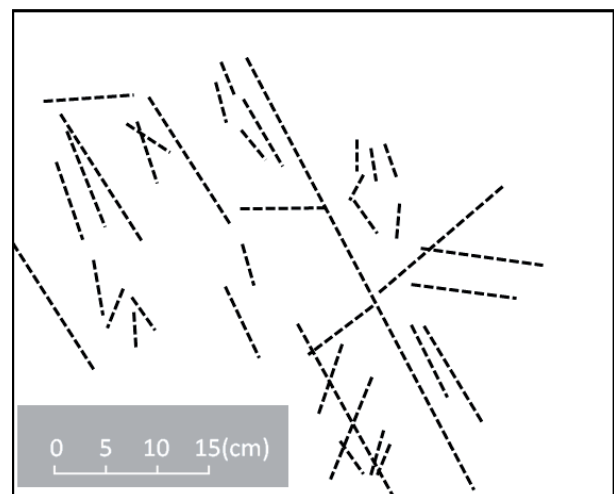
Fig. 10. Sketch of streak line on trench surface of Photo 7

As shown in Photo 7 and in Fig.10, many streak lines were found on the face of trenched section of platform and foundation mound. Based upon the photos of the sections, the streaks were analyzed in the part of squared section of “Area of Analysis of Streak lines” shown in Fig.8.

Since the internal frictional angle of sand obtained by laboratory test was 30 degrees,  $\theta$  become 30 degrees when the vertical overburden stress is the major principal stress. The appearance of these streak lines suggests that the foundation mound might have experienced plastic yielding under vertical load.

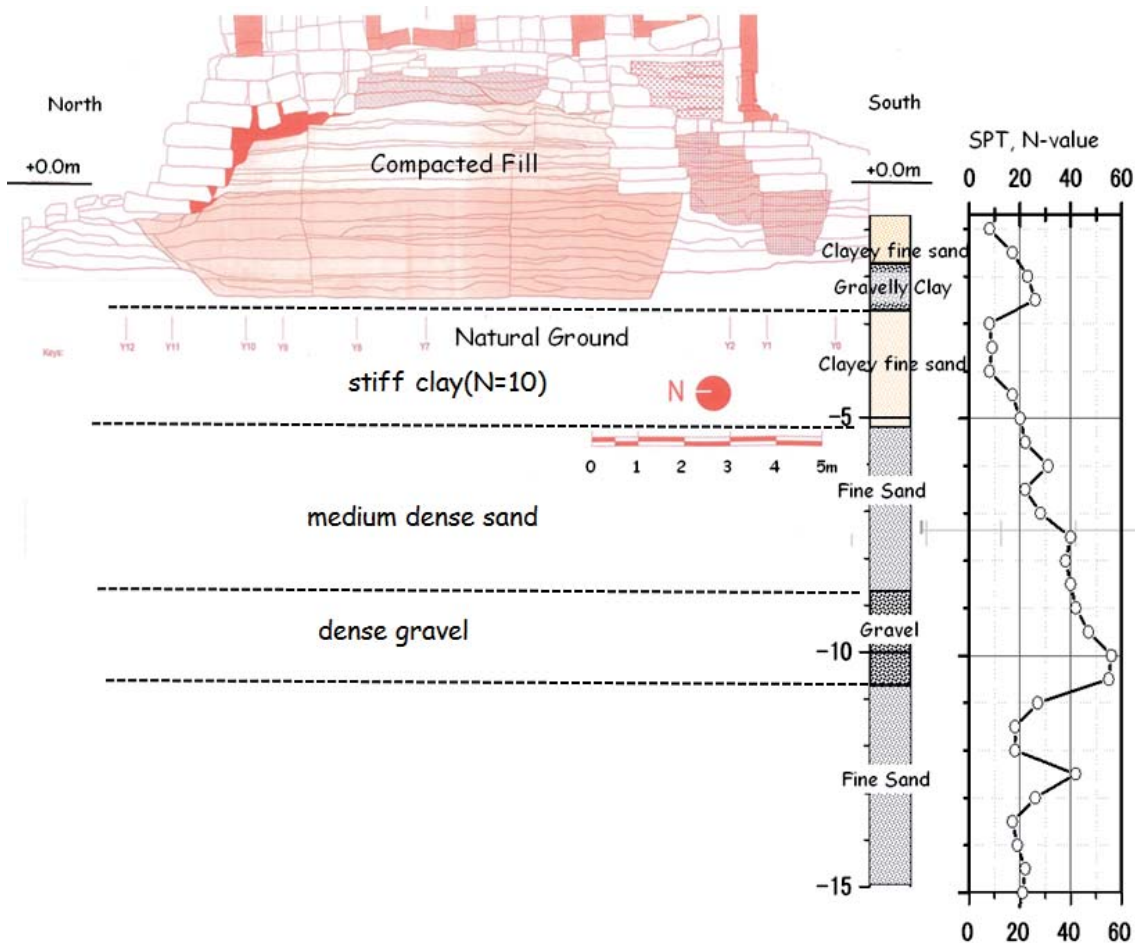
Fig.13. Geotechnical Condition near N1 Tower, Prasat Suor Prat

Geotechnical condition at the site is shown in Fig.13. Beneath the compacted sand mound, stiff clay (N=10) of natural formation follows some 3m. There are medium to dense sand and gravel layers below the stiff clay.

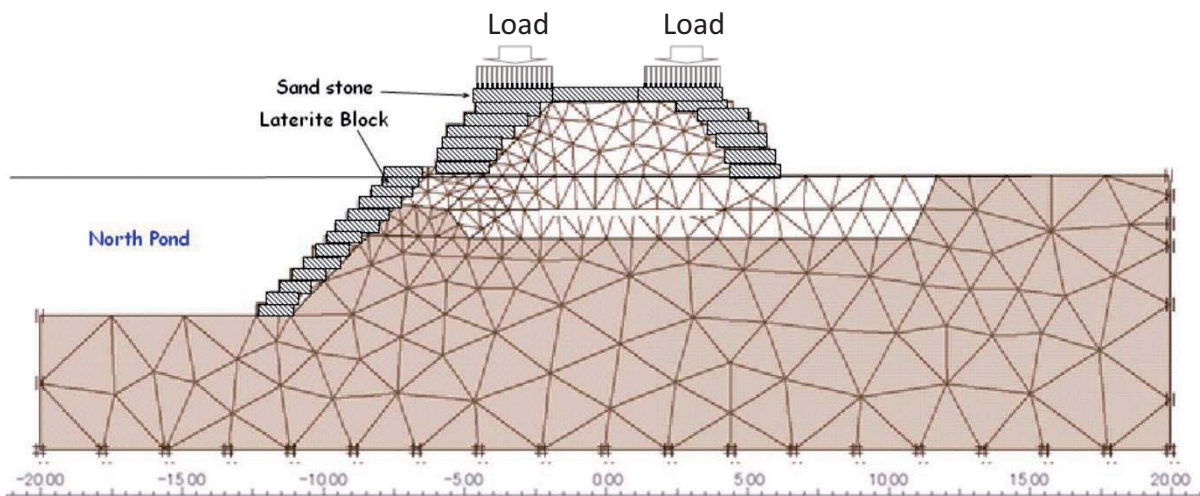
Fig.14. FEM mesh by PLAXIS 2D

The soil parameters are based upon some typical number estimated by the authors. However, the FEM results suggest the essential features of the characteristics of deformation of the Tower.

The seasonal change of level of underground water might have affected the strength of the soil mound and repeated nature of weakening soil mound has caused yielding of the mound and the
