ACTIVE FAULTS AND CHARACTERIZATION IN OSAKA AND ALMATY BY BORING DATA BASE

Abstract

The active fault in Osaka is known as Uemachi fault, which had been originally identified as geomorphological feature of the Osaka high terrace. However, the position of the fault line was corrected by geotechnical information during subway construction.

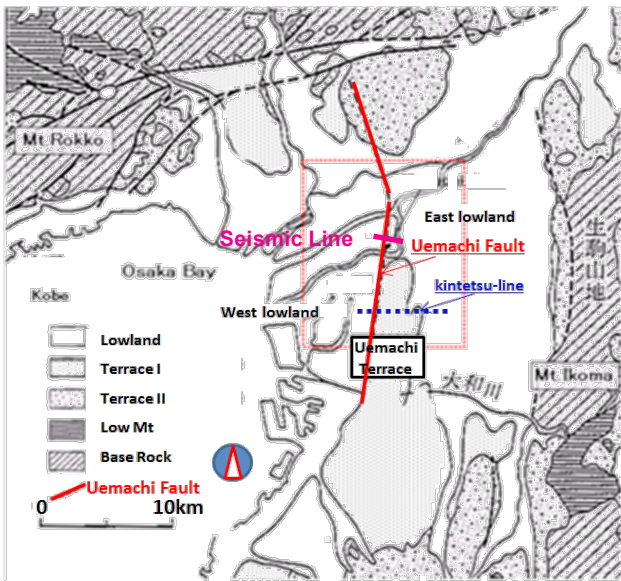
Figure 1. Uemachi fault identified along the edge of Uemachi terrace (1960)

Basically active faults in Osaka area distribute along such lines of mountain foot as well as line of edges of terraces of recent young geological deposits. These are based upon geomorphological feature of the present mountains and terraces that have been made by fault movements as shown Figure 1.

In Figure 1, Uemachi fault is identified as the western edge of the Uemachi terrace in Osaka city. When a subway construction for Kintetsu-line that is crossing with the Uemachi-fault showed the geological section along the line as in Fig.2, it was found that the real fault is not on the edge of the terrace but some 500 m away to the west. The height of the western side of the ground is about +10m and that of the eastern side is about +20m.

A seismic reflection survey was performed along the seismic line in Fig.1. The result was shown in Figure 3. The underground feature of the fault was clearly identified by the reflection survey.

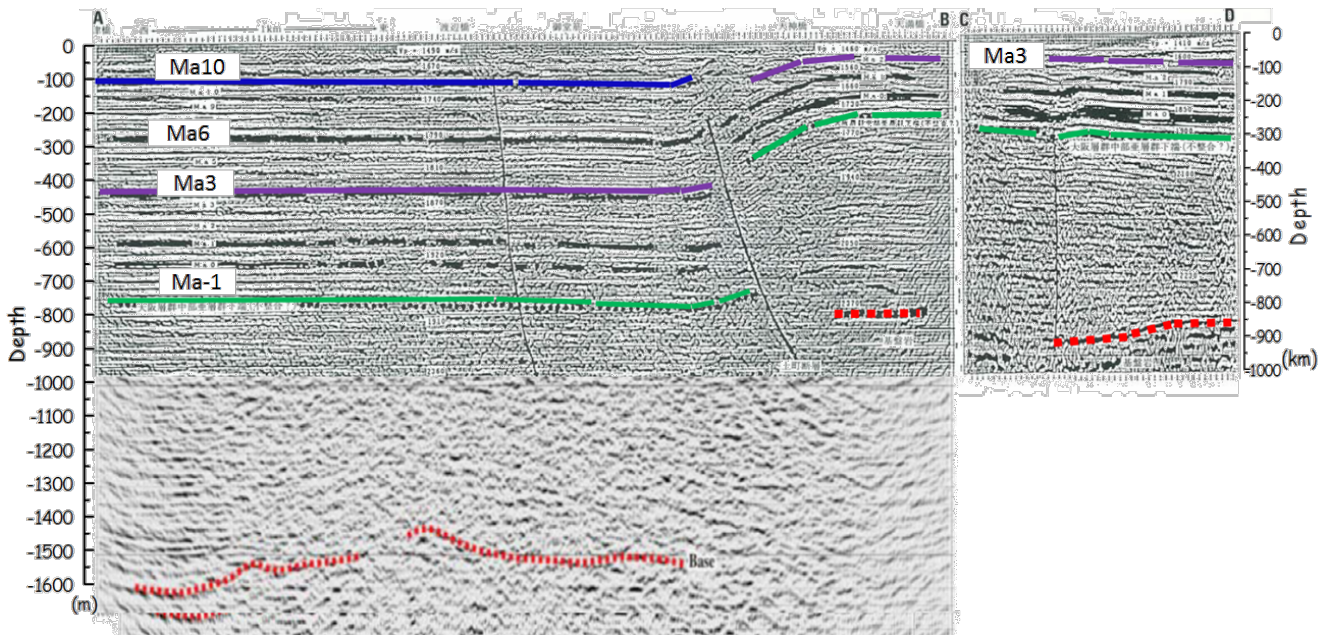
Figure 3. Nakanoshima seismic reflection line (1991)

The depth of the base rock near the east and the west end of the surveyed line was about GL-800m and GL-1500m. The difference of the depths of the base rocks is considered as the fault movement in the past of 3million years from present.

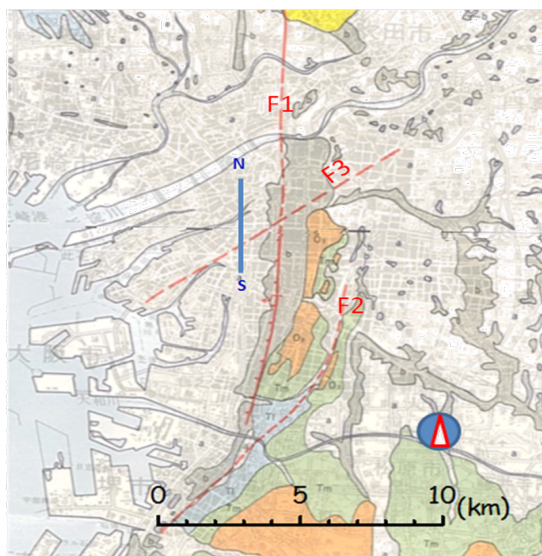
Figure 4. Fault map in Osaka in 1980

Fault map in Osaka was revised after the recognition of the geotechnical study along the subway line as shown in Figure 4. The Uemachi fault was shown westwards in the geological map in 1980. At the same time, two additional faults lines were added as Fault 2 and 3. Fault 2 was estimated along the topological feature of the terrace in the south Osaka.

Fault 3 was estimated by not from surface topology but from the underground structure.

Geotechnical boring data system in Osaka began in 1980 and some special feature was recognized along the line of "Fault 3" in Figure 4.

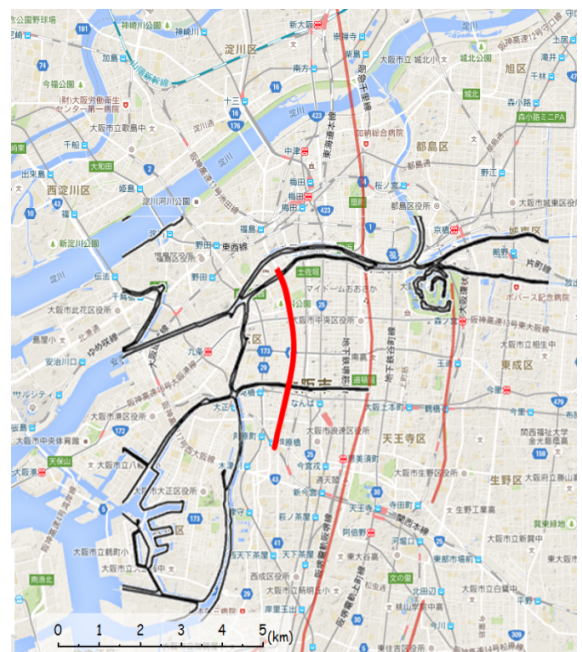
Figure 5. Seismic line along the fault

We recommended seismic reflection as well as deep boring including the line of N-S in Figure 5. The result is shown in Figure 7. The geophysical result shows the underground structure that was expected by geological study based upon geotechnical database.

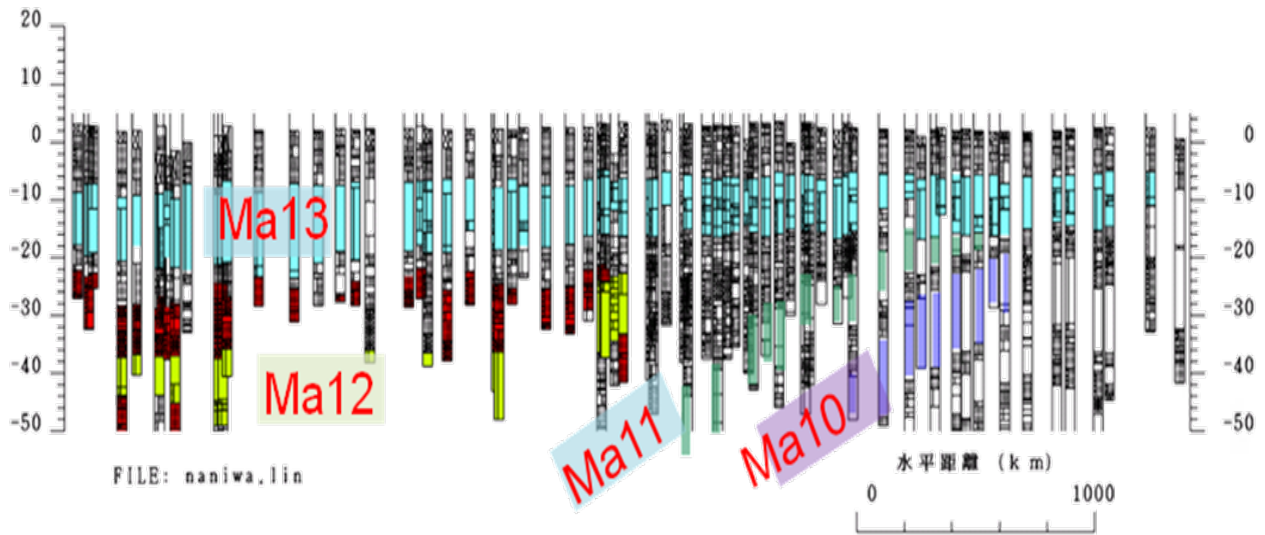
Figure 6. Geological section based upon geotechnical boring system in Osaka

Figure 4 shows a typical boring section along N-S line in Figure 3, where Ma13 of the recent deposit of clay layer is horizontal formation. Those layers of Ma11 and Ma10 are inclined towards north and the Ma12 is also inclined towards north but seems deposited horizontally at the north end. This unique combination of the horizontal layer of recent deposit with inclined formations of the earlier deposit was found along the fault line of "F3" in Figure 4.

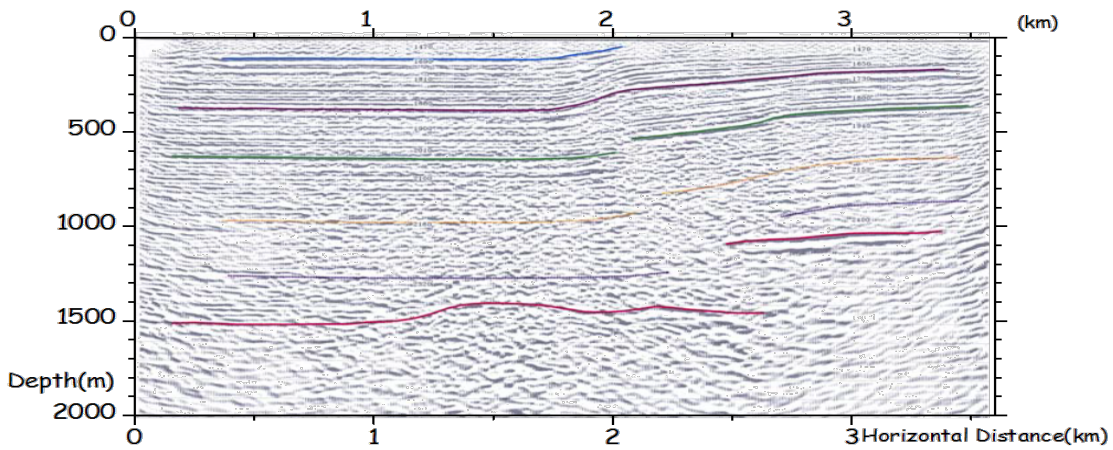
Figure 7. Seismic reflection along N-S line in Figure 5

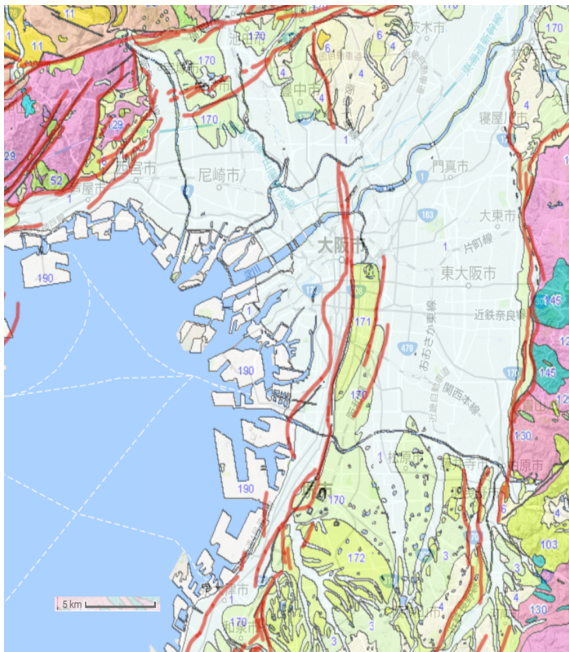
Figure 10. Active faults in Osaka (Geological Survey of Japan as of 2018)

At present in 2018, Geological Survey of Japan shows tectonic active faults as in Figure 10. Figure 11 shows

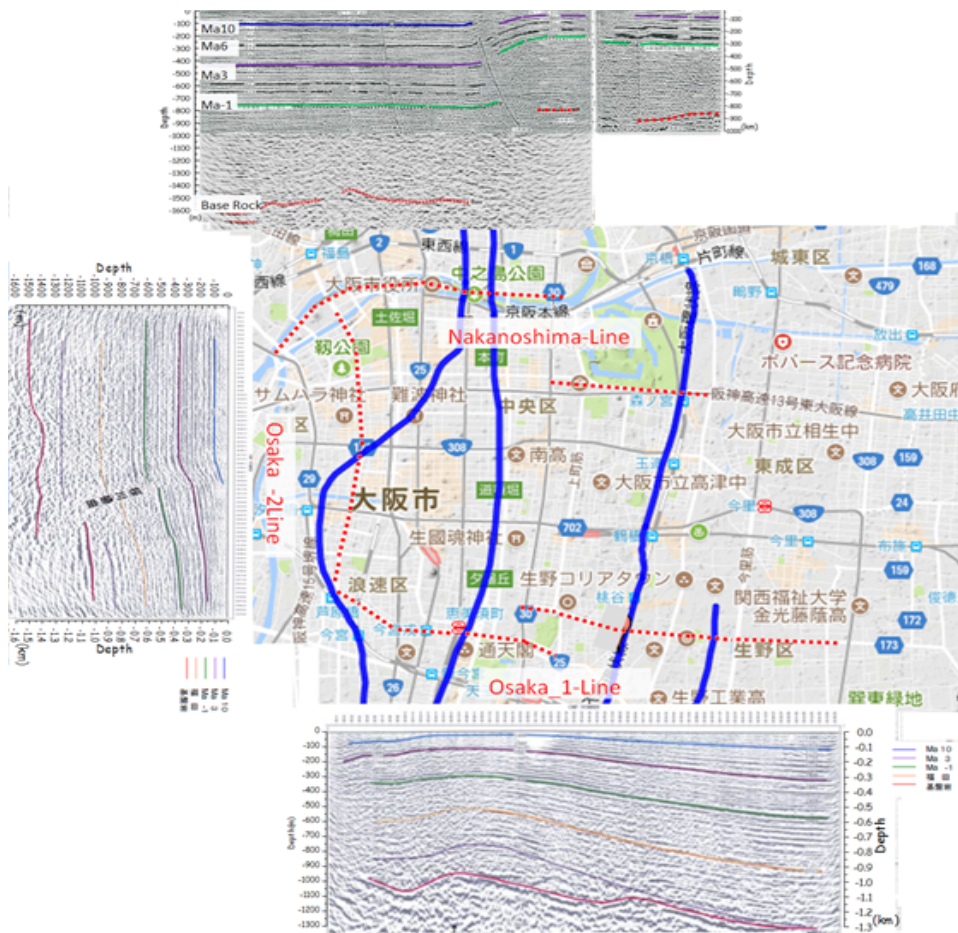
Figure 11. Seismic reflection results in Osaka

The base rock is clearly recorded by the survey and is shown at the GL-1,000m to 1,300m. The shape of the image does not show any fault gap of the displacement along the line, which contradicts the existence of the faults indicated by the geological survey of Japan. The faults in Osaka area are not strike slip with any vertical displacement but reversal dip slip with some vertical slip component.

The seismic reflection of Osaka 2-Line shows the clear fault structure of different depths of the rock. The depths of rock at the north and south sides are 1,500m and 1,000m.

some comparison between the active faults by Geological Survey of Japan(GSJ) in blue lines and seismic reflection results. It is found the estimated faults by GSJ do not correspond with the reflection survey. For an example, reflection line Osaka-1 show no deformation at four points where it crosses with the expected faults. We need to study more detailed structure to clarify the fault systems in Osaka.

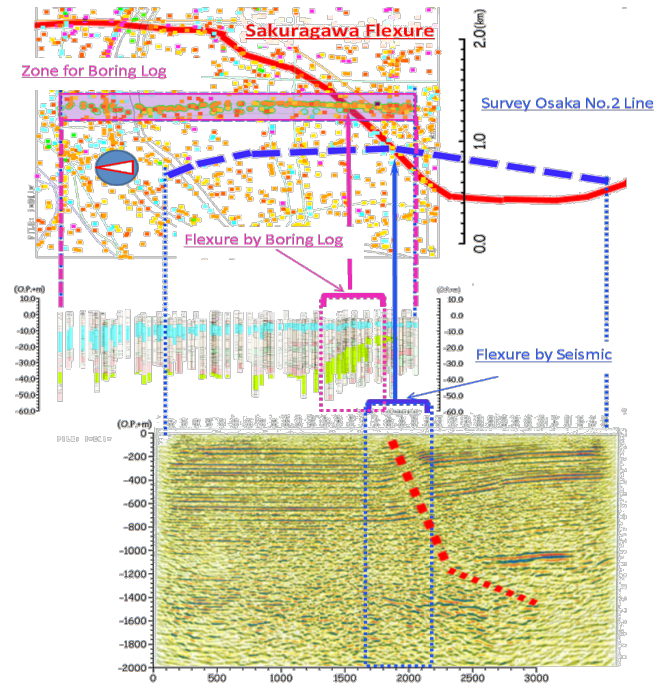
Figure 13. Boring data base along the studied line in Figure 12

Figure 12 shows active fault lines and subway lines and indicates crossing points of the faults and subway lines. Figure 13 shows the distribution of boring points in the area and the selected zone along the subway line in the Figure 12. Figure 14 shows the characterization of fault movements as the flexure of two parameters.

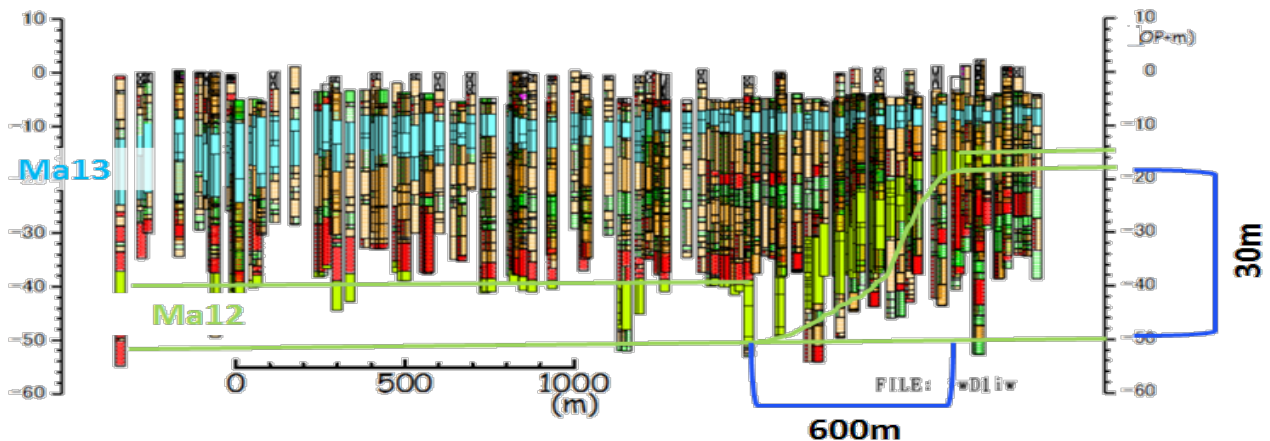
Figure 14. Characterization of the Fault movement of Ma12

The vertical displacement and the width of the fault as dip = 30 m and width =600 m respectively.

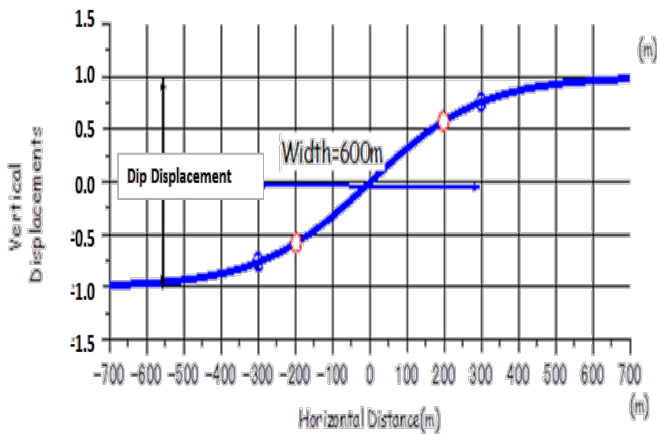
Figure 15. Anticipated deformation of the fault

The anticipated deformation of the surface ground is shown in Figure 15.

Several important aspects of the fault displacements to the life line structure are 1 inclination, 2 flexure moments, 3 tension and compression strains caused by flexure mode of displacement, and overall compression strain caused by reverse fault.

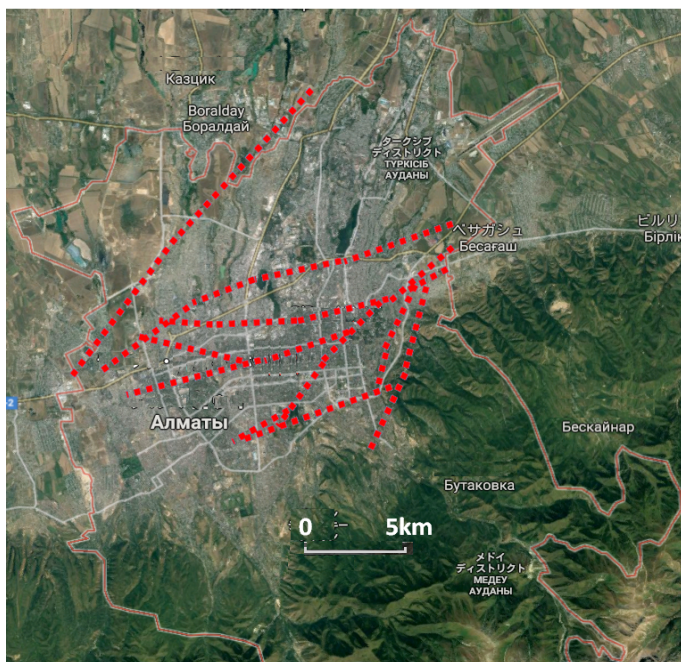
Figure 16. Fault Lines in Almaty (JICA (2009))

The active faults in Almaty in Kazakhstan were studied by geomorphological character of the surface topology and shown as in Figure 17. Almaty area is located at the north of the Tien Shen Mountain that is tectonically very active being pushed by Indian continent.

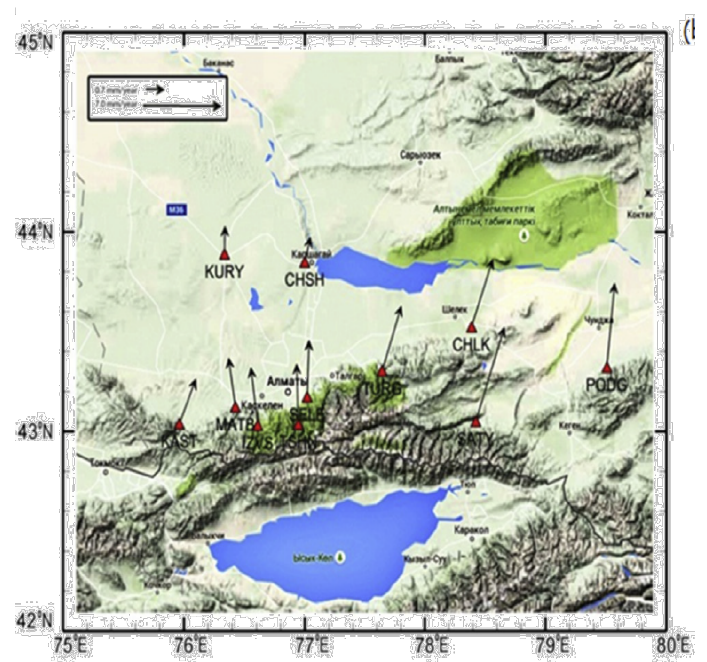
Figure 18. Crustal velocity by GPS monitoring (Vilaev (2017))

As shown in Figure 18, GPS monitoring shows GPS movements in Almaty shows northwards displacement of about 7 mm/year, which results in compression strain in NS and expansion strain in EW direction that shall induce the reverse type of fault plane in EW direction as well
